# Harbour Cove Depreciation Report

1450, 1470 & 1490 Pennyfarthing Drive, Vancouver, BC

Draft Report: August 10, 2016

Final Report: May 2, 2017

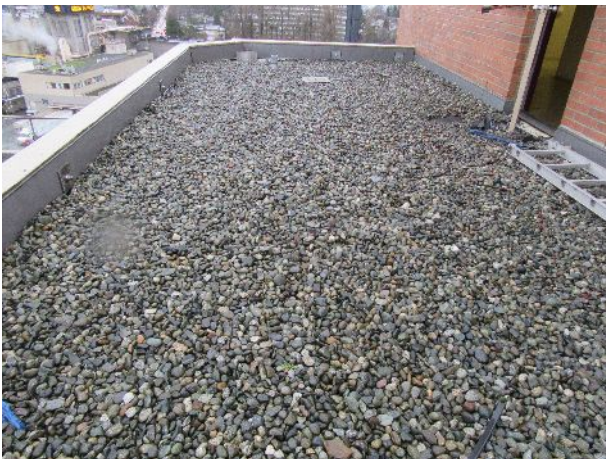
The expected service life, present equivalent age and condition relate to the original single-ply inverted roofing assemblies. Some of the original inverted roofing was replaced after approximately 25 years of service (1450 penthouse and mechanical room roofing), but we do not believe that this is indicative of the service life of the remaining original roofing. The strata corporation meeting minutes indicate that epoxy crack injection has been done at locations below the roofing in the 1470 and 1490 buildings in the past. The first roofing replacement project includes the original roofing over the 1470 and 1490 entrance canopies and the 1490 building. The second roofing replacement project relates to the the inverted roofing over the 1450 mechanical room and penthouse roofs in the 2040/41 fiscal year given that they were replaced circa 2006.

1 – Inverted roof over 1450 penthouse unit

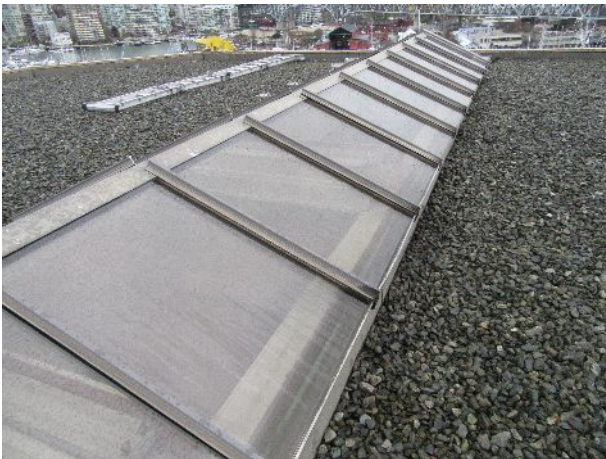
RJC's 2014 Building Envelope Condition Assessment (BECA) documented that the T-bar skylights had poor interface detailing, which renders them susceptible to air and moisture leakage. No significant deterioration of interior finishes was noted below the T-Bar skylights at the time, but in late 2016, leakage was observed to be emanating from the 1490 skylight. We do not believe that the leakage was the result of condensation. The 2014 BECA recommended that these skylights be replaced with improved pressure cap skylight assemblies by 2019 (fiscal year 2018/2019). An upgraded skylight assembly will have better water drainage capacity and improved air tightness, resulting in a decreased likelihood of water damage to the interior finishes and improved thermal performance. Replacement of IGUs in the T-bar skylight assemblies should be avoided if replacement of the skylights is imminent.

2 – Skylight over unit in 1490 building

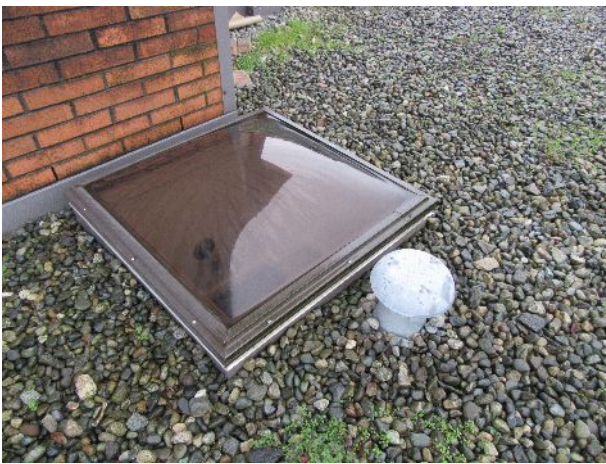
RJC's 2014 Building Envelope Condition Assessment (BECA) documented that no significant evidence of leakage was observed beneath the acrylic dome skylights and no significant issues were raised by the occupants with the exception of condensation issues. Condensation is typical of single-glazed skylights and windows. We expect that the funds for skylight replacement can be drawn from the operating budget as required. Given that a better installation can be achieved when replacing the skylight and surrounding roofing at the same time, if the skylights are close to the end or past their expected service life, we recommend that the owners replace the skylights when replacing the roofing membrane in the surrounding areas.

3 – Acrylic dome skylight on 1470 roof

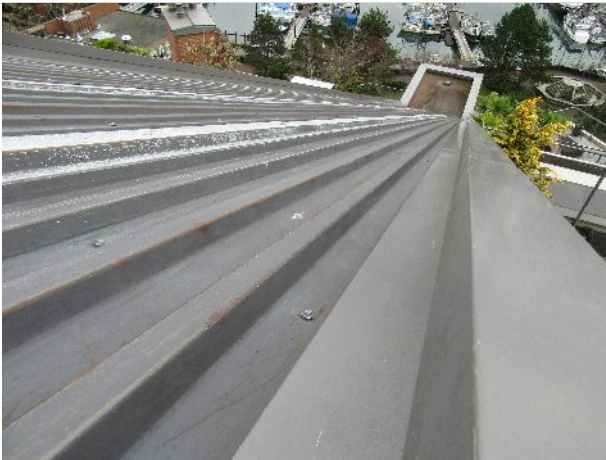
We expect that, after the replacement project, re-painting of the metal roofing, replacement of fasteners and fasteners gaskets can be funded from the operating budget as required. If this renewal work is undertaken approximately every eight to ten years, we do not believe that the metal roofing will require replacement in the next 30 years. To generate some economies of scale, the painting of the metal roofing should be combined with the larger building painting project.

5 – Metal roofing over 1450 stairwell

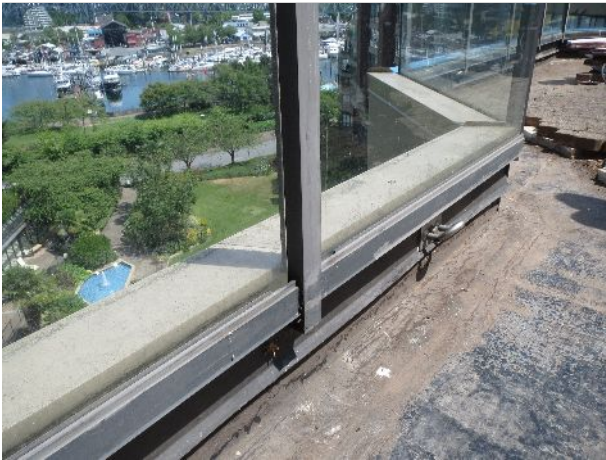
The expected service life, present equivalent age and condition relate to the original single-ply inverted roofing assemblies. Some of the waterproofing on these decks has failed while some is approaching the end of its service life. A budget has been provided for the replacement of three decks per year. Based on our involvement with the past roof deck waterproofing membrane replacement projects and information received by the strata council, we understand that 21 of the 42 roof decks are complete. The budget is based on the 2016 costs for the replacement of the waterproofing membrane on three roof decks.

7 – Exposed roof deck membrane (2015)

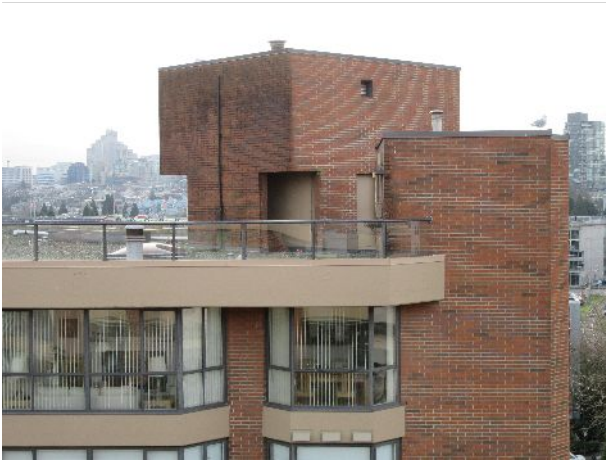
Since at least 2006, the brick veneer has been deteriorating (cracking, spalling, mortar erosion, bulging, etc.). Many repairs have been made to the brick veneer, in particular at the courses of brick immediately above and/or below the supporting shelf angles and concrete corbels. We understand that many of the horizontal joints just below the shelf angles were filled with mortar and this contributed to the deterioration. These joints should be filled with sealant to allow for movement. We also understand that, based on a 2006 structural report and RJC's 2014 Building Envelope Condition Assessment (BECA), numerous weep holes are obstructed and not performing as intended. The slower discharge of accumulated water behind the brick veneer may be resulting in corrosion of the shelf angles. This in turn may have caused deterioration of the brick above the shelf angles. We expect that the brick veneer will continue to require repairs in the future. The service life is based on our understanding of the brick veneer deficiencies and the high likelihood of future repairs. The budget includes consulting engineering fees.

12 – Brick cladding at 1490 building

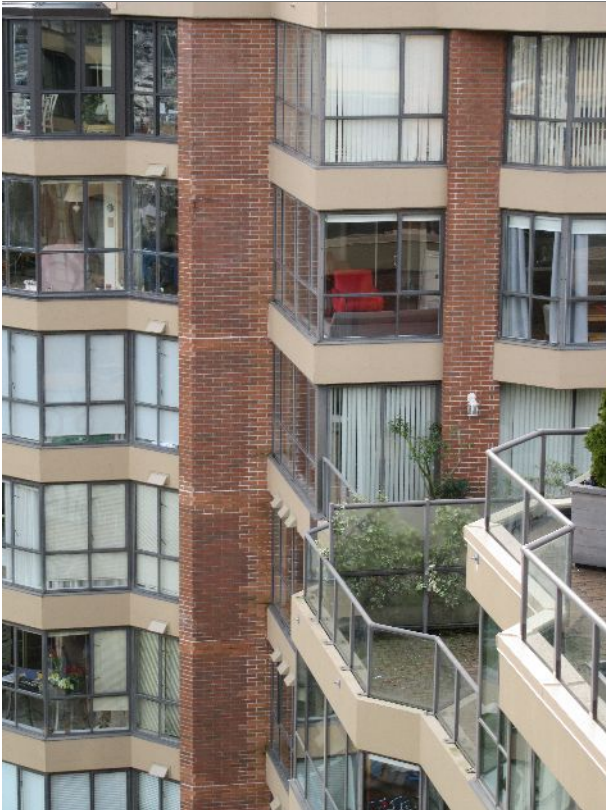
13 – Past brick veneer repairs

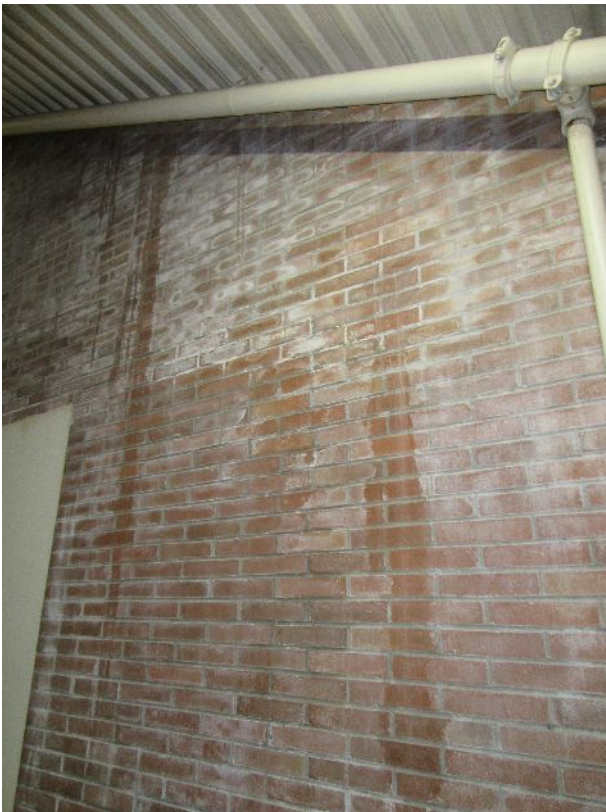
Active leaks and widespread efflorescence were observed on the inside face of the structural brick walls of the 1450 stairwell. We believe that the leaks and efflorescence is due to inadequate or poorly installed waterproofing at the interface between the stairwell walls and adjacent roof decks. As the waterproofing is replaced on the adjacent roof decks, the portion of the stairwell wall which is accessible from the roof deck is re-pointed where necessary (to address failed mortar joints or previous mortar joint repairs with inappropriate materials) and sealed with a brick sealer. We expect that the leaks into the stairwell will be addressed with this work. Once the waterproofing membrane replacement is completed on the adjacent roof decks, we recommend that the efflorescence inside the stairwell be removed to determine if any leaks are still active.

14 – Structural clay brick wall in 1450 stairwell

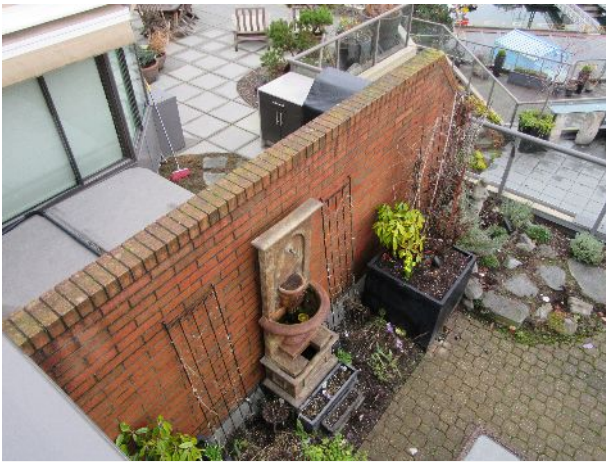
Moss was observed growing in the joints of the coping, which will lead to deterioration of the joints. To increase the likelihood that that the walls will not require replacement in the next 30 years, we recommend removing the moss annually and carrying out targeted re-pointing of the mortar joints. A repair budget has been provided to re-point these walls every ten years. To significantly extend the service life of the walls, we recommend replacing the brick coping with metal cap flashing or precast concrete coping which extends past the face of the wall.

15 – Brick privacy wall

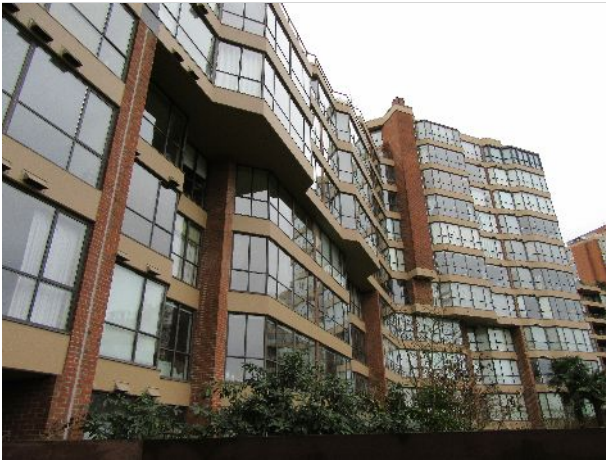
We believe that some of the windows have reached the end of their service life and the remaining windows will soon be at the end of their service life and require replacement. In the 2014 report, RJC recommended replacement of the windows over a ten year period, beginning in 2014. This depreciation report has reduced the project to four phases and deferred the start of the work, beginning in the 2019/2020 fiscal year. We recommend that the prioritization of the four contiguous areas of work be based on the findings of the 2014 BECA report in combination with observations of leakage from occupants. The estimated remaining service life represents the average service life of the windows. Some have already failed and some will fail after the indicated service life. The budget includes replacement of the original and recently installed windows (by individual owners) with thermally broken aluminum-framed windows, replacement of the brick around the windows (in order to achieve a proper tie-in with the adjacent wall assembly), replacement of the remaining original solarium skylights with thermally broken aluminum-framed skylights, restoration of interior finishes and consulting engineering fees.

16 – Windows overlooking east courtyard

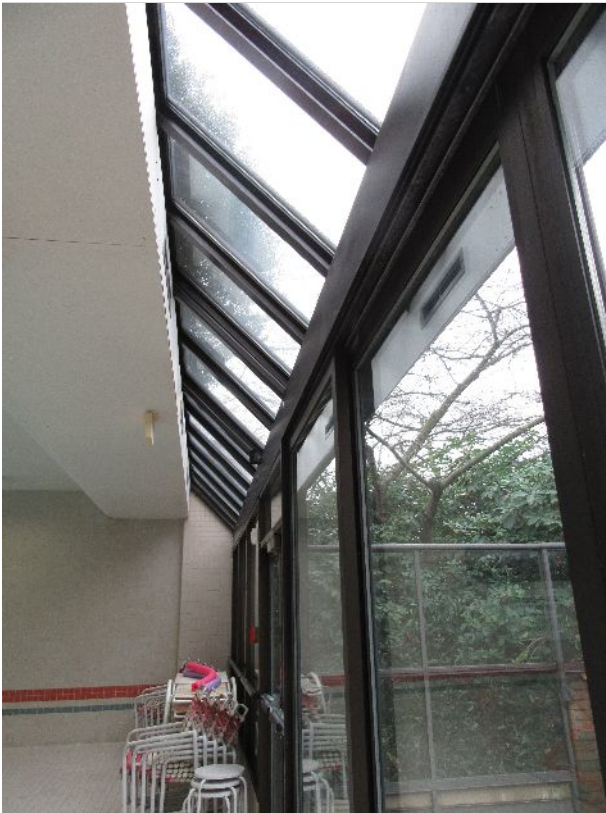
We do not expect that the storefront glazing at the 1450 and 1490 entrances will require replacement in the next 30 years, but the entrance doors within the storefront assembly likely will. A budget for entrance door replacement has been provided in BE.18.

18 – Storefront glazing system of pool area

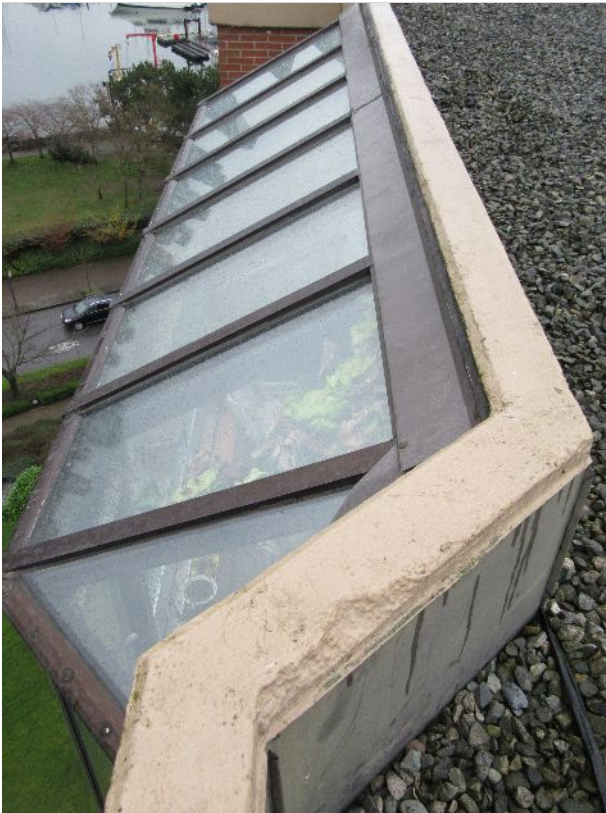
The strata corporation meeting minutes and RJC's 2014 Building Envelope Condition Assessment do not document leaks through the skylight over the pool area (in the roof) and above the storefront glazing system on the south wall of the pool area, although vegetation was observed to be growing through the base of the skylight over the pool. Because a better transition between skylight and the adjacent roofing membrane can be achieved if both are replaced at the same time, the budget for replacement of the skylight over the pool is included in the plaza slab waterproofing budget which includes replacement of the roofing over the pool area. The replacement of the skylight over the storefront glazing system is included in the budget to replace the storefront system.

19 – Solarium skylights at 1490 building

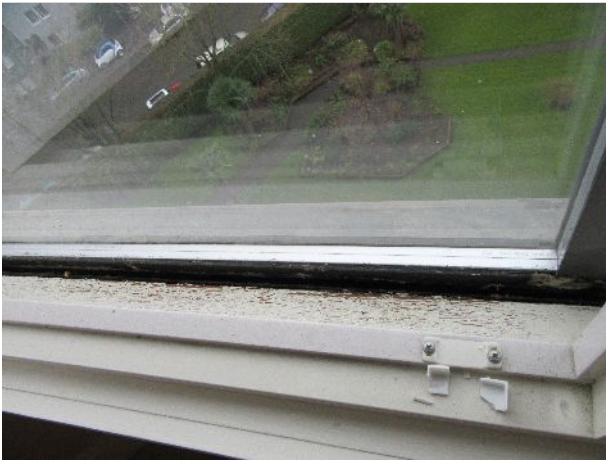
20 – 1985 IGU in 1490 building

As noted in RJC's 2014 Building Envelope Condition Assessment (BECA), we recommend that all replacement IGUs include a low emissivity (low E) coating to reduce the solar gain in the warmer months of the year.

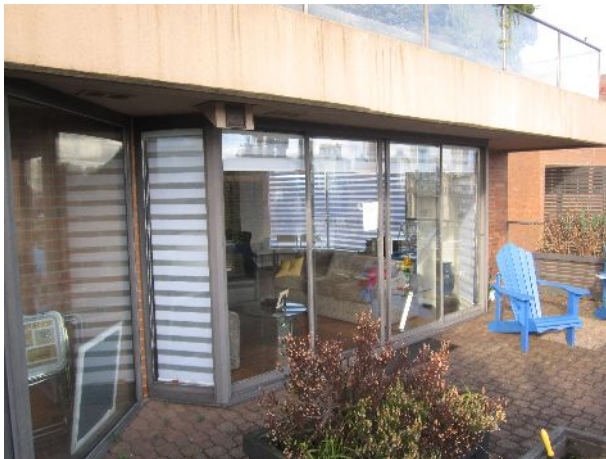
RJC's 2014 Building Envelope Condition Assessment documented that many occupants were complaining of air leakage, water leakage and difficulty in operation. During this field review, some of the doors were difficult to open and close, presumably as a result of rollers which require replacement. Replacement sliding track rails were installed on some of the lower tracks. We recommend that rollers be assessed annually and replaced before they begin wearing out the rails of the bottom track. We expect that the assessment can be undertaken by the building manager and the funds required for roller replacement can be drawn from the operating budget without significant impact. The replacement budget includes removal and reinstatement of the exterior cladding around the doors (in order to achieve a proper tie-in with the adjacent wall assembly), restoration of interior finishes and consulting engineering fees.

22 – 1450 roof deck sliding doors

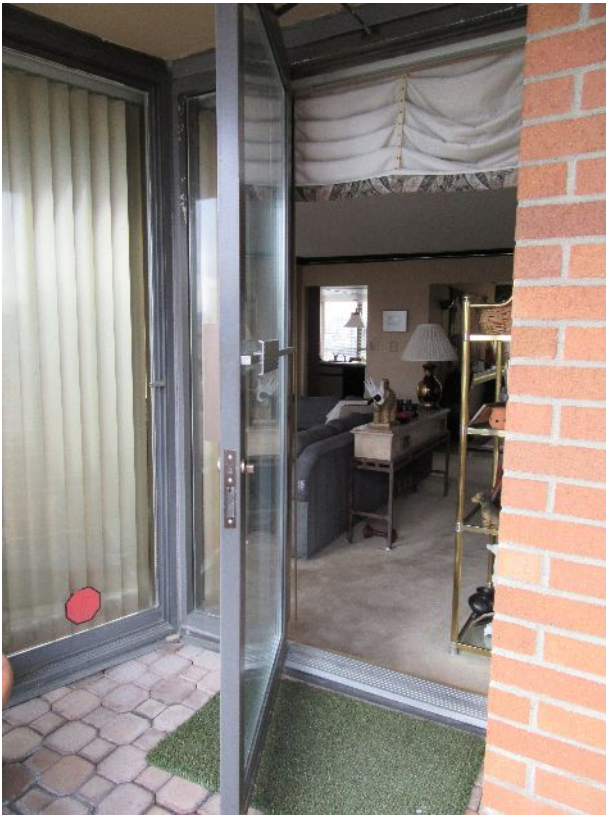
Some of the doors were somewhat difficult to lock due to misalignment between the door leaf and door frame. We expect that the operating budget will be used to fund maintenance of and repairs to the swing doors until they are replaced. The replacement budget includes removal and reinstatement of the exterior cladding around the doors (in order to achieve a proper tie-in with the adjacent wall assembly), restoration of interior finishes and consulting engineering fees.

23 – Aluminum-framed swing door at 1450 roof deck

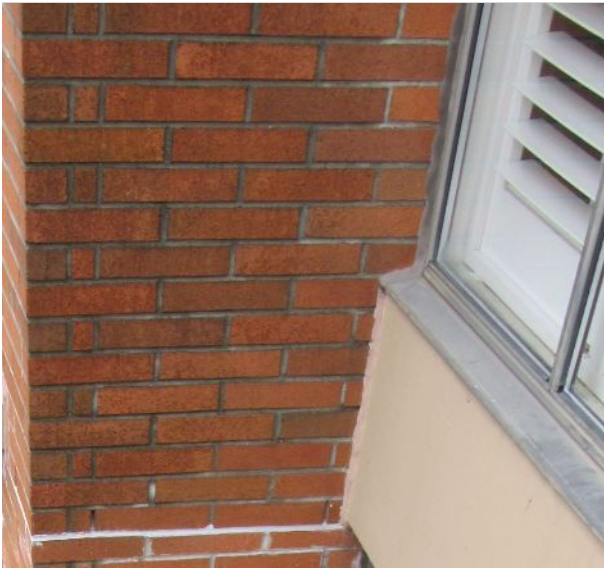
Because we do not expect that all of the sealants will fail at the same time, a budget has been provided to replace approximately one quarter of building sealants at five year intervals. The budget includes an assessment by a building enclosure engineer to determine which part of the building envelope to target for sealant replacement. This replacement program takes into account the sealants which will be replaced during other building envelope projects such as window replacement, brick veneer replacement and sliding door replacement. The expected service life represents an average service life. The actual service life of the sealant will vary based on exposure to UV radiation, thermal cycling, range of movement, surface preparation and application.

26 – Sealant at edge of and in brick veneer

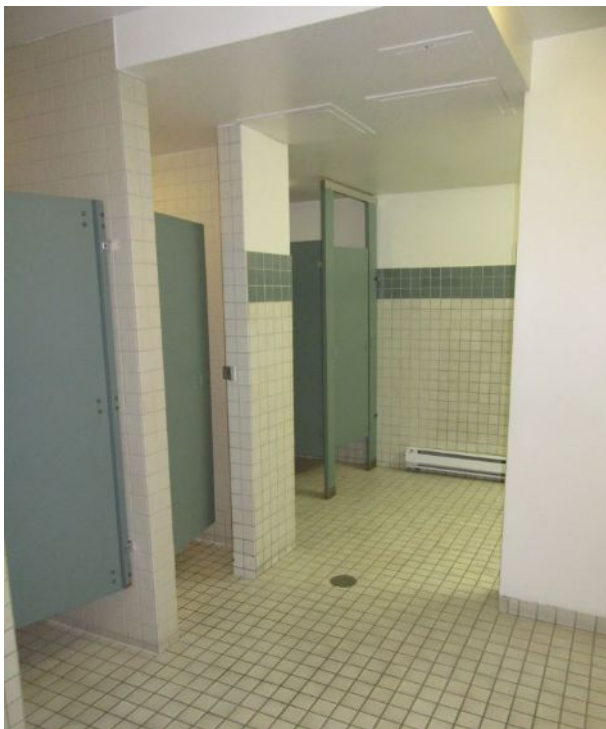
To reduce costs, the owners could consider reducing the extent of wall tile and re-using the plumbing fixtures, faucets and electric baseboard heaters (which appear to have been replaced recently). We do not expect that the shower stalls or lockers will require replacement in the next 30 years. If not already being done, we recommend re-sealing the tile flooring at five year intervals. This will reduce the likelihood that the tiles will delaminate from the concrete deck and ensure that the moisture content of the concrete slab below remains low.

48 – Men's change room

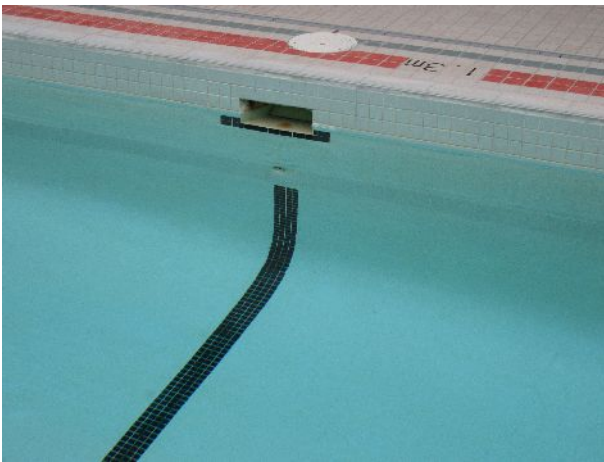
We assume that the plaster waterproofing was replaced once since original construction. Some transverse cracks were observed in the plaster and evidence of leakage was observed in the bicycle storage area under the suspended pool. Some dark staining was also observed on the grout (and to a lesser extent on the surrounding tile) in one area above the waterline (hot tub side of pool). The present equivalent age has been reduced to account for these observations.

51 – Pool tank finished in tile and marcite plaster

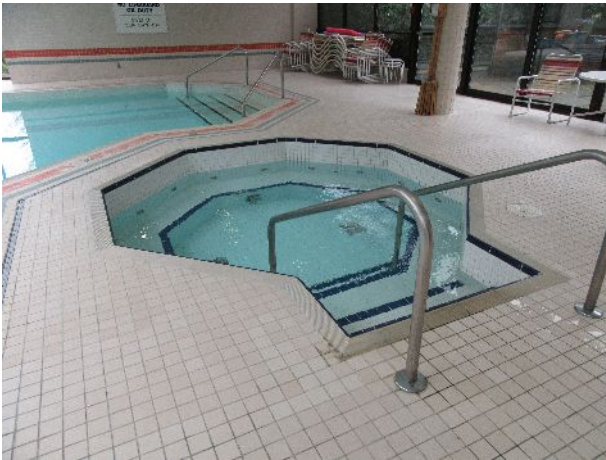
Significant evidence of leakage (including at least one active leak) was observed below the hot tub (in the pool and hot tub filtration and sanitization service room). Because the grout is the most likely point of water infiltration, we recommend that the hot tub be re-grouted approximately every five years after the tiling is replaced. We expect that the required funds for re-grouting the hot tub can be drawn from the operating budget without significant impact.

52 – Hot tub in pool area

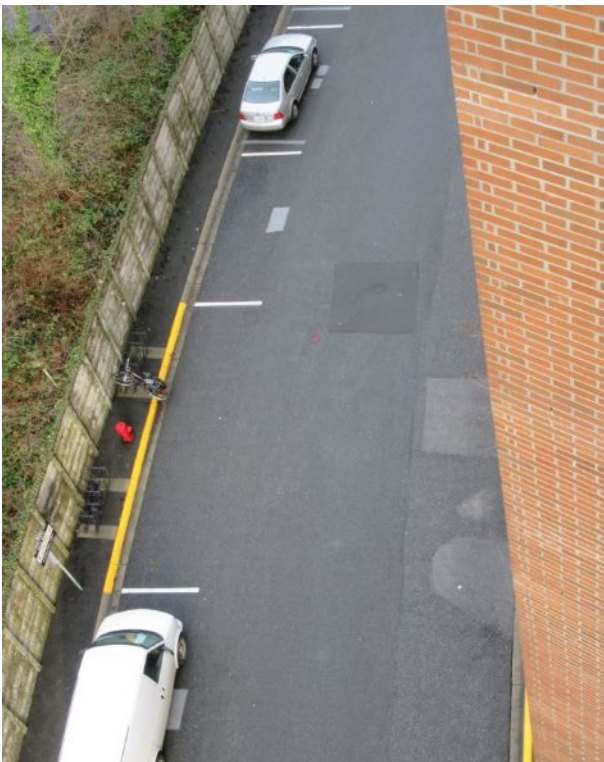
57 – Pennyfarthing Drive

Until full re-surfacing, we recommend that crack sealing be undertaken every two years to ensure that water run-off does not reach the compacted base through cracks and undermines the base. The saw cuts and perimeters of the asphalt patches should also be sealed. Undermining of the base often results in deterioration and settlement of the pavement which in turn results in additional and increasingly larger patches. Crack sealing should reduce the number of future patches and likely delay full re-surfacing. We assume that the operating budget can be used to fund biennial crack sealing and line painting.

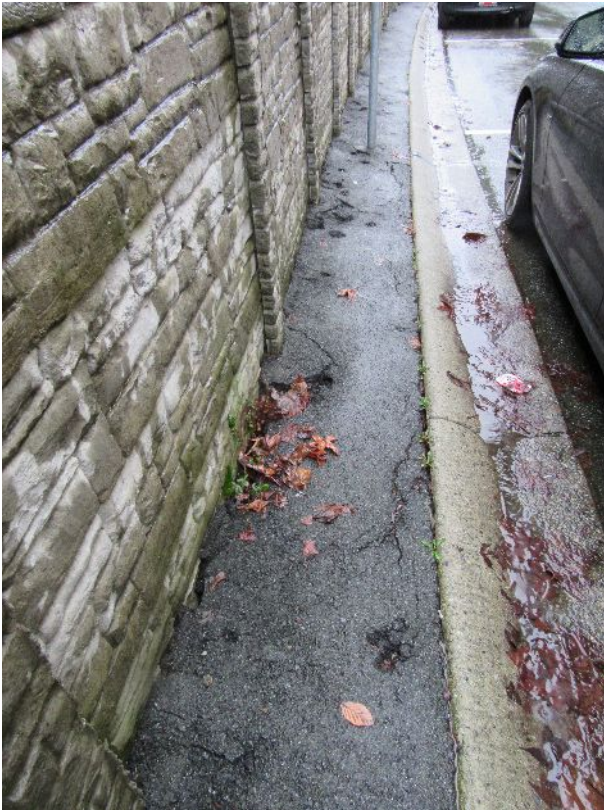
Based on the settlement issues along this walkway and the fact that it is used much less frequently than the sidewalk on the east side of Pennyfarthing Drive, we recommend that the owners consider simply replacing it with compacted gravel. Compacted gravel would be less expensive to install and easier to maintain if settlement issues are ongoing.

58 – Asphalt walkway west of Pennyfarthing Drive
