Harbour Cove Depreciation Report

1450, 1470 & 1490 Pennyfarthing Drive, Vancouver, BC

Final Repo : May 2, 2017

RJC Project: VAN.103675.0022

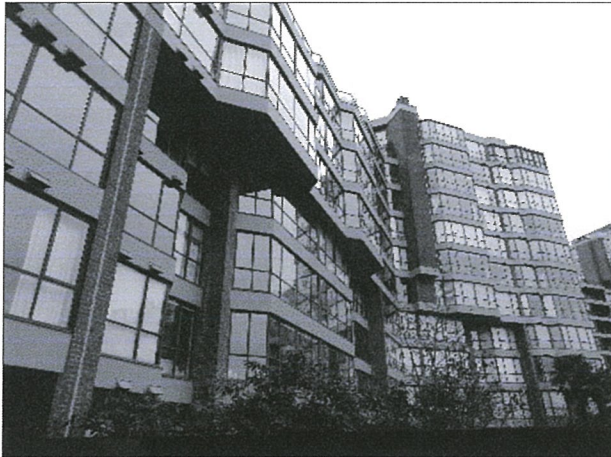
Some of the exterior rubber gaskets were not properly secured in place or were not continuous. Some latches were missing on the common area windows and several window latches were loose. Leakage to the interior was observed at one window. Sealant was observed on the outside of several windows, presumably to mitigate water ingress.

16 – Windows overlooking east courtyard

We believe that some of the windows have reached the end of their service life and the remaining windows will soon be at the end of their service life and require replacement. In the 2014 report, RJC recommended replacement of the windows over a ten year period, beginning in 2014. This depreciation report has reduced the project to four phases and deferred the start of the work, beginning in the 2019/2020 fiscal year. We recommend that the prioritization of the four contiguous areas of work be based on the findings of the 2014 BECA report in combination with observations of leakage from occupants. The estimated remaining service life represents the average service life of the windows. Some have already failed and some will fail after the indicated service life. The budget includes replacement of the original and recently installed windows (by individual owners) with thermally broken aluminum-framed windows, replacement of the brick around the windows (in order to achieve a proper tie-in with the adjacent wall assembly), replacement of the remaining original solarium skylights with thermally broken aluminum-framed skylights, restoration of interior finishes and consulting engineering fees.

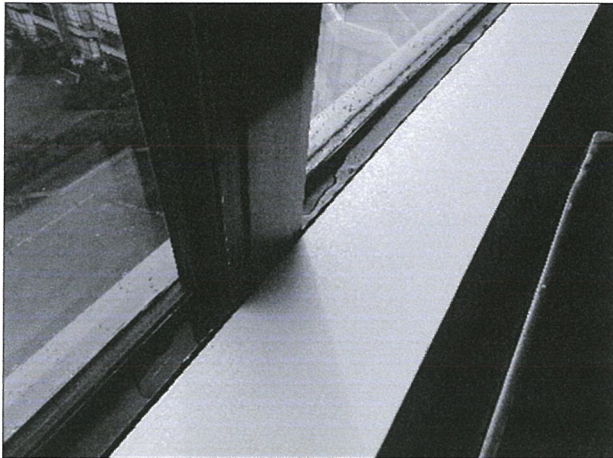
17 – Window leak in Unit 901 - 1470

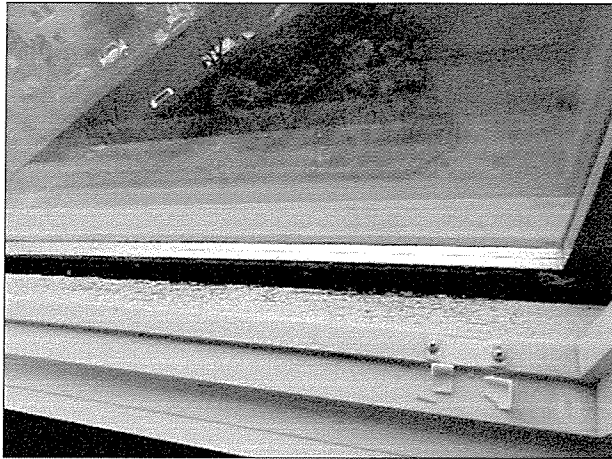
Given that the IGUs have a different service life than the windows, exterior doors and skylights of which they are a part of, the IGUs for the complex are categorized independently in this appendix. The strata corporation meeting minutes indicate that many IGUs have been replaced over the last five years. Several failed IGUs were observed during the field review. Some of the IGUs in the corridors on the west side of the complex were partially delaminated from the metal spacers. This may pose a safety risk and should be addressed as soon as possible.

20 – 1985 IGU in 1490 building

As noted in RJC's 2014 Building Envelope Condition Assessment (BECA), we recommend that all replacement IGUs include a low emissivity (low E) coating to reduce the solar gain in the warmer months of the year.

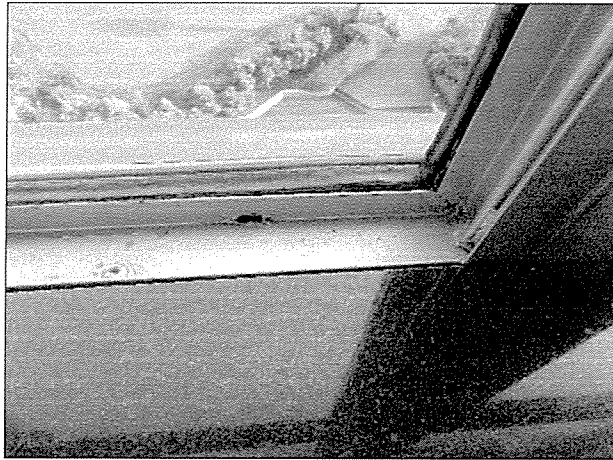
21 – IGU in 1470 building

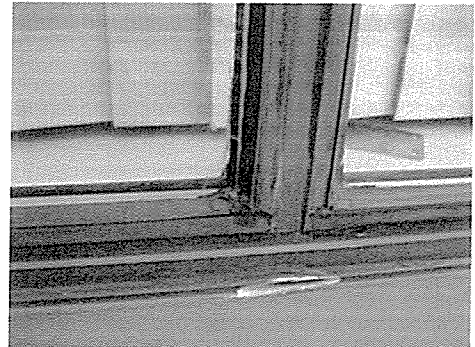
- .4 Damaged and deteriorated exterior sealant was observed at a number of locations around the window and door assemblies. The sealant joints have failed at several of these locations. The maintenance of sealant joints in mitigation of water ingress at these conditions is critical.

Photo 2: Glazing seals cut short and filled with failed sealant allows water to penetrate the window assembly.
