Layton Consulting was retained by the strata at Harbour Cove, 1470 Pennyfarthing Drive, Vancouver, BC to investigate the existing window system at the same address. Layton Consulting is an engineering consulting firm specializing in glazing and cladding design.

This report was prepared to assess conditions of the original windows and to determine whether or not the existing windows need remediation and/or replacement. An on site meeting and review of the windows was conducted on June 17, 2010. Eric Skytte, ASCT of Layton Consulting and the strata council were present at the review. *This report is mostly limited to the structural integrity of the windows only.* Existing water ingress, caulking or sealant issues are not reviewed to a great extent due to the visual only review.

Figure 1 – Site overview, Harbour Cove, 1470 Pennyfarthing Dr, Vancouver

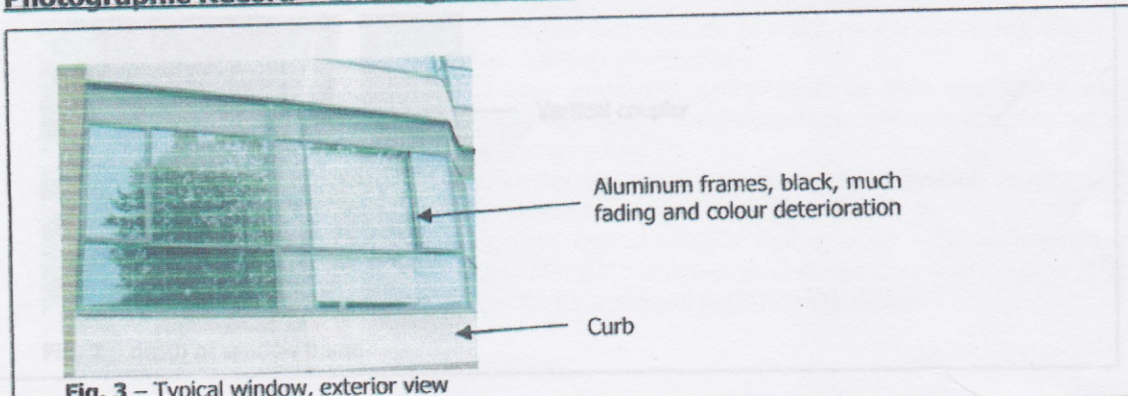
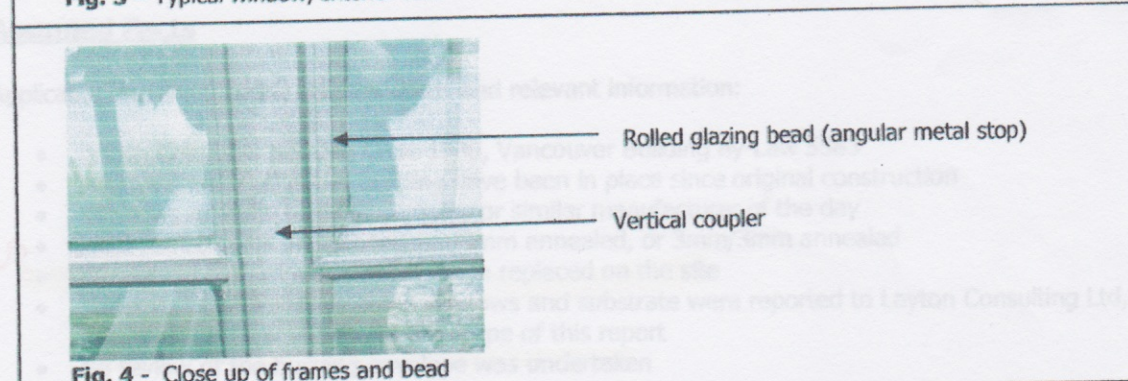
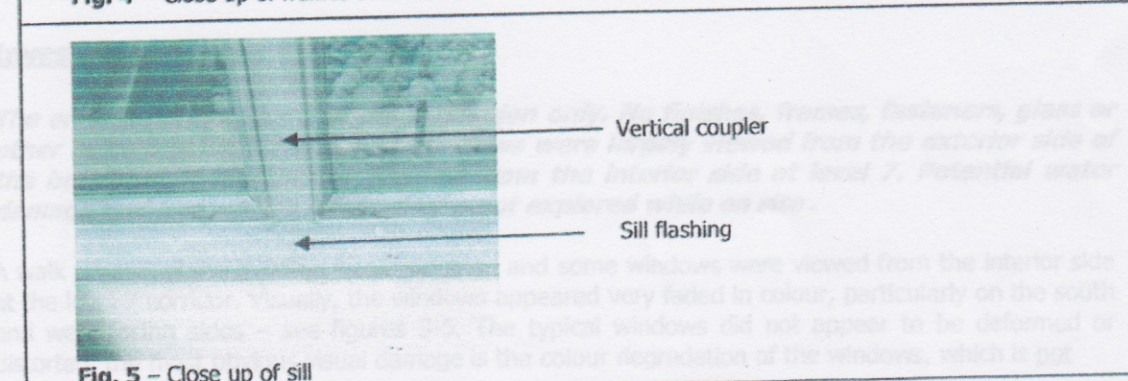
A walk around of the building was conducted and some windows were viewed from the interior side at the level 7 corridor. Visually, the windows appeared very faded in colour, particularly on the south and west facing sides - see figures 3-5. The typical windows did not appear to be deformed or distorted, the most obvious visual damage is the colour degradation of the windows, which is not

- We recommend that additional screws be added to the existing windows at the jambs and sills to provide added securing and stiffness to frames.
 - Consideration should be given to installing new rolled glazing beads and perhaps re-painting the existing frames on the exterior (these items can be priced out to see if cost effective).

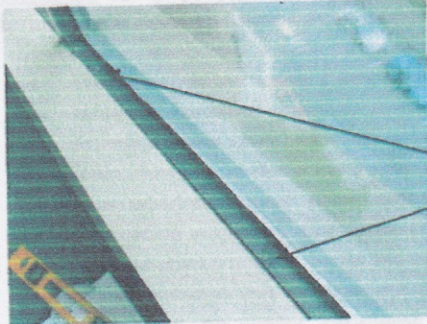
Fig. 6 - window sill fastening

Screws into window sill

- Fastening of the windows to the substrate was typically as much as 24- 30" apart, which is generally not adequate for high-rise windows of this size
- Some of the sealed units (IGU's) have significant degradations to both the spacer bars (which hold the two glass pieces together) and to the glazing tape, which is bleeding out of the frames in some locations - see figures 9 and 10

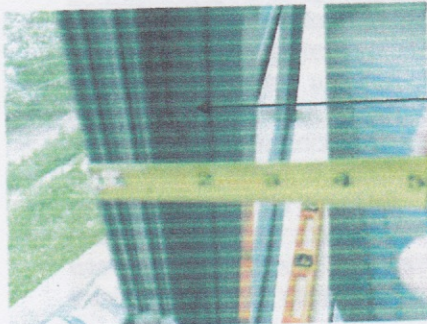
Fig. 7 - depth of window frame

Vertical coupler

- As previously noted, a significant number of sealed units have failed, causing fogging and condensation within the glass - see figure 10
- Frame profiles are smaller than today's typical window wall systems - for example, the windows on Harbour Cover are typically 2¾" deep; a modern window wall system is at least 3½" to 4½" deep - see appendix for assumed profile configurations

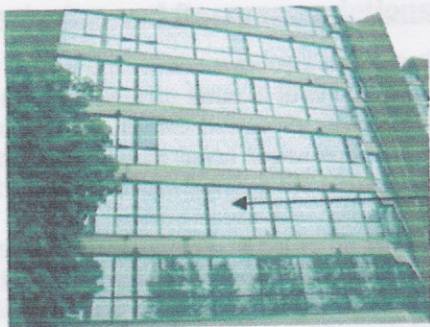
Fig. 8 - typical window sizes and configurations

- The window panel sizes within each unit are somewhat large as is the span of the horizontal mullions, but fairly typical for windows installed within high-rise buildings at the time of construction - see figure 8

Typical largest glass panel (IGU)

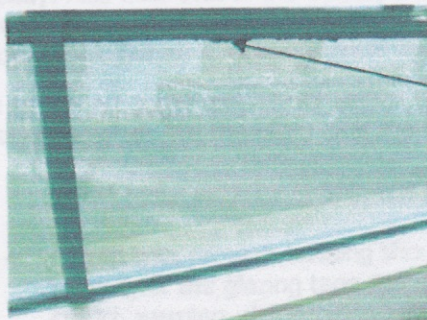
Fig. 9 - glazing tape degradation

Glazing tape 'bleed out'

Conclusion – The typical glazing tape should have a width of at least 0.47" (1/2"), however with the bleed out at many of the units, the actual bonding width of the tape still inside the frame is less than this amount. The seals may already be in the process of rupturing at these locations and will continue to do so, leading to further water ingress

- All windows on each building should be reviewed from the interior **and** exterior to check the integrity of the glazing tape and spacer bars; the spacer bars should be visually reviewed for cracks, warping, deformation, etc, (i.e. as shown in Figures 9, 11); the glazing tapes should be checked for bleed out and detachment from the window frames and glass; any of the

- New sealed units should be installed with a modern double sided glazing tape; these products are better than the tapes provided in the 1980's and will help ensure the glass is adequately secured to the window frame.

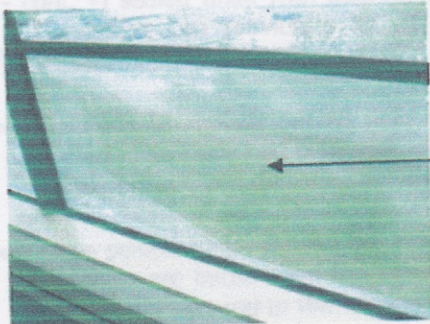
Fig. 10 - sealed unit failure

Sealed unit fogging

- Continue to replace sealed units that have failed and are fogging up, leaking, etc. The sealed units likely had a 10 year warranty and the need to replace many of these units is to be expected given that they are already 25 years old.

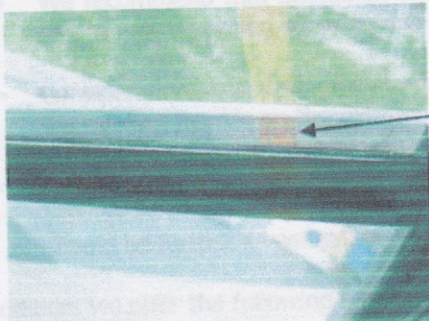
Fig. 11 - spacer bar degradation

Space bar degradation -
cracking, fading and
warping

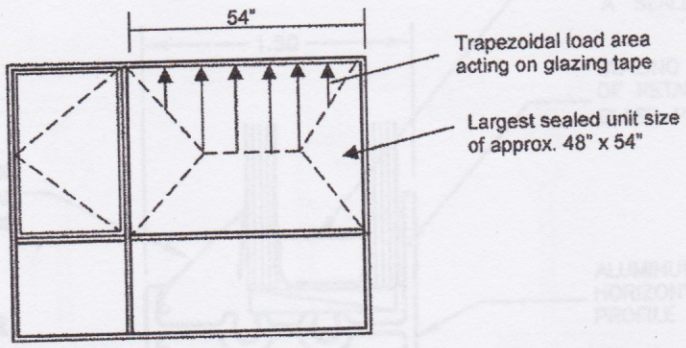
Glazing Tape Check

Calculation of width of the adhesive bond is calculated by the trapezoidal load distribution theory. Flat plate glass distributes the loads to the tape and the mullions in a trapezoidal load area as shown by the diagram above. Typical bonding design stress of glazing tape is 12 psi, an industry accepted standard which includes an appropriate margin of safety

Assuming the highest wind load design used on this high-rise was approx. 30 psf under earlier building codes, we can check to see the required width of the tape to adequately secure the glass to the window frames, based on the following formula:

- Stress (ULS) wind load; $p_{net} = 30.00 \text{ psf};$
- Longest dimension of sealed unit; $L = 54.00 \text{ in};$
- Bonding material design stress of glazing tape; $s = 12.0 \text{ psi};$ (Older tapes may be less)
- Structural bite width; $B_w = (0.50 \times L \times p_{net}) / (s \times 12 \text{ in/ft}) = 0.47 \text{ in};$
