Given the long history of leaks in various parts of our suite over the 25 years we have been living in it and what was revealed when the living room window wall was opened earlier this year, you will understand our interest in the WSP report entitled *Harbour Cove Moisture Content Survey* and dated 29 August 2017. **Unfortunately it gives us no new useful information for our own suite and there are serious questions about its value to all owners in terms of meeting the stated objectives in the Scope of Work and information needed by owners for deciding on actions.** Below we detail our reasons for the most disappointing conclusion that the WSP report is deeply flawed.

#### Pictures from our Suite 211-1450

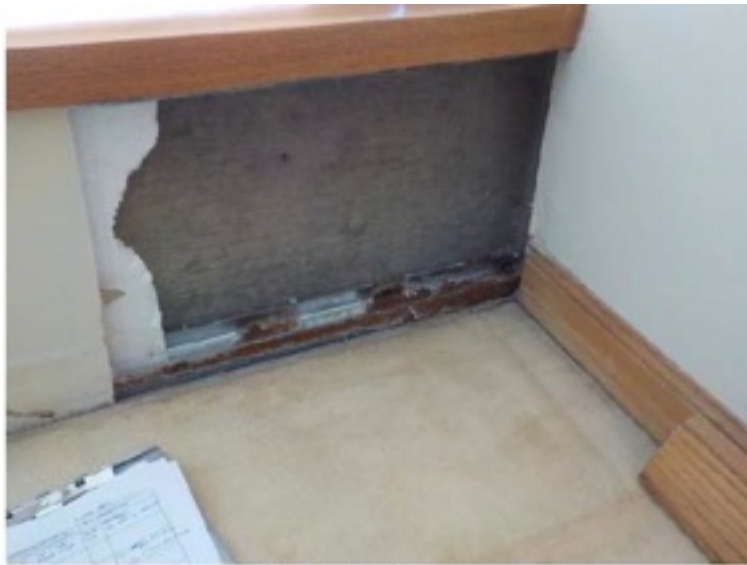
1450-Unit 211 - Corrosion on steel stud

This picture is taken from p. 2 in Appendix D of the WSP report. You will recognize it as showing the leak damage to plaster, steel and carpeting that was found when Ciprian had Vlad open the wall in our **sitting room** on 16 February 2017. Not shown in this summer photo by WSP is the fact that water was streaming down the concrete when it was opened during the rainy season and such events have clearly been going on long enough for the rust to eat completely through the steel in places.

Since the new hole cut in the **Dining Room** wall only exposes a 1.5” square of concrete, the comment in the Observation column, “Corrosion on steel stud”, **cannot be referring to the studs in the dining room wall as they cannot be seen**. Again, it obviously refers to the large opening in our **sitting room** that we have had to look at for the last 8 months.

If, as seems very likely, it is a reference to the condition of the studs in the **Living Room** wall the statement “Corrosion on steel stud” seems a **major understatement** given there is **substantial rusting and places where the rust has completely eaten through the steel, indeed enough to create a series of holes**. This is readily obvious to the naked eye. To say less is to seriously misrepresent the condition of the steel and mislead HC owners who read the report as to the extent of the problem in our suite **and** quite possibly hidden behind the walls of others (a potential problem that our RJC consultants have cautioned owners to anticipate since the BECA Report 2014 and the Depreciation Report 2016).

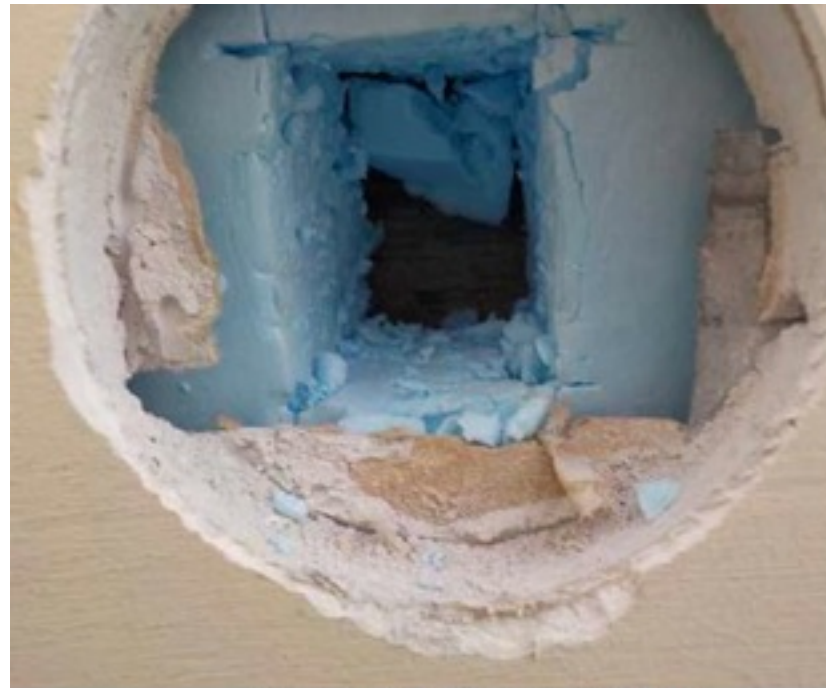
1450-Unit 211 - XPS rigid insulation

This second picture also appears on p.2, next to the one above, and shows the 3" examination hole cut by WSP in a similar location below the window in the adjacent **dining room** wall. The hole cut in the styrofoam is only 1.5" wide and 2" high. The concrete wall exposed for inspection at the back is even less, about 1.5" square.

*“...and consisted of 3” holes through the dry wall to expose the exterior wall assembly.”*  
It is not clear what the specific intent was in cutting 3” holes in terms of precisely the observations about the “exterior wall assembly” that were being sought. The picture above for the 3” hole cut into the dining room window illustrates what **can and can not** be identified by the chosen method as it was implemented. The hole as cut through the drywall and the styrofoam is adequate to identify the material layers (i.e. drywall, styrofoam, concrete). **But** is not large enough to observe anything more about “the exterior wall assembly” than the very small 1.5” square of concrete. No view to left or right or up and down is possible. Given the problems revealed by opening our **adjacent sitting room** wall, it is very surprising that the investigator did not see reason to make a more careful examination of what has happened over time behind the **dining room** wall. All it required was an enlargement of the hole for visual inspection and/or use of a video camera.

*“A moisture content reading was taken at the exterior sheathing, where possible...”*  
Are we correct in assuming that “exterior sheathing” refers to the interior face of the exposed concrete, as seen in the above photo for the dining room hole, an area of 1.5” square? This detail on location is essential for interpreting the significance of the measurements recorded. As reported the reader has no idea whether the measurements recorded came from the “exterior sheathing” or somewhere else. The investigator’s choice could have major implications for interpreting the Moisture Content recorded.

As explained above, the small access created would **not** enable them to detect “**any** evidence of moisture or prior water ingress”, **only** that within the small 1.5” square. The report makes a seriously misleading over-statement.
