# Harbour Cove Depreciation Report

1450, 1470 & 1490 Pennyfarthing Drive, Vancouver, BC

Draft Report: August 10, 2016

Final Report: May 2, 2017

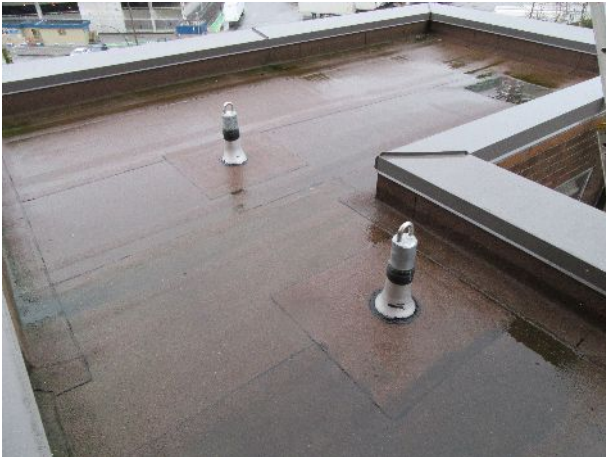
Based on a review of the strata corporation meeting minutes and our past involvement with this complex, our understanding is that most of the existing modified bitumen membrane roofing was installed between 2008 and 2012. The present equivalent age represents an average age of the modified bitumen roofing assemblies. The replacement budget includes replacement of cap flashing and insulation. Although this report consolidates replacement of all the modified bitumen roofing to generate some economies of scale, the accrued funds can be used to replace the roofing as leaks begin to occur in each roofing assembly. Separating the project into smaller projects would increase the overall cost.

4 – 1470 stairwell roof

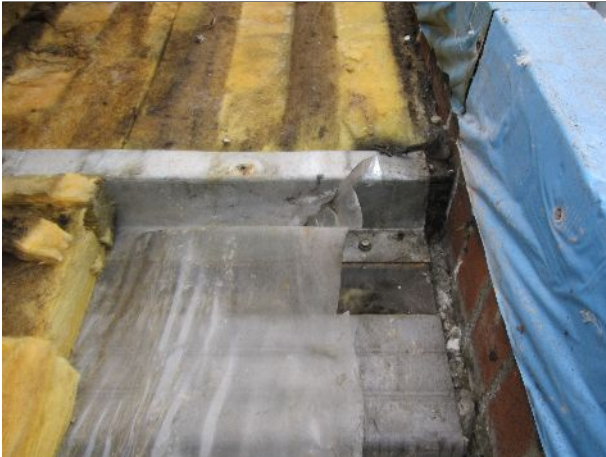
6 – Exposed metal roof assembly (2015)

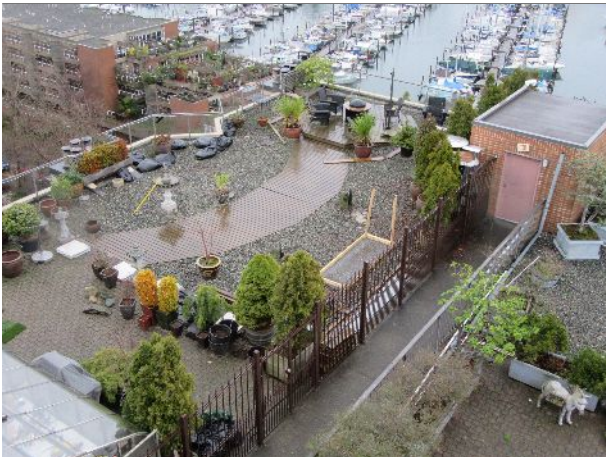
8 – 1450 roof decks

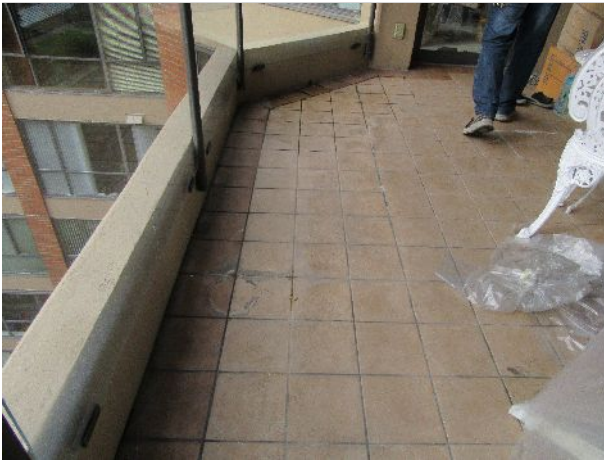
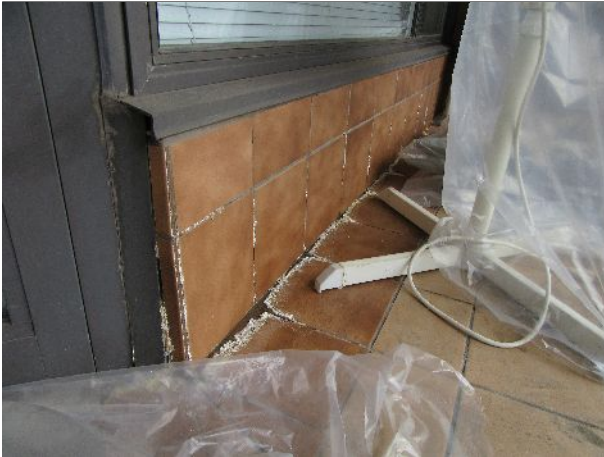
9 – Tiled balcony at 1450 building

10 – Tiled wall below balcony window

Although the budget is based on the scope of work already established by the owners, we recommend that the owners consider limiting the waterproofing system to a two-ply, liquid-applied traffic deck coating given its cost effectiveness as compared to a two-ply, sheet membrane assembly with unit pavers. We recommend that the owners install this more cost-effective waterproofing for the balconies on the 1490 building. We also recommend that new scuppers be installed where existing scuppers are too high to provide adequate drainage. The budget to repaint the painted balcony decks of the 1490 building is included in the building painting budget.

Given that the proper installation of a waterproofing membrane involves removal of the brick and tile on the walls surrounding the balcony decks, we recommend that the owners consider replacing or adding a waterproofing membrane together with replacement of the brick veneer.

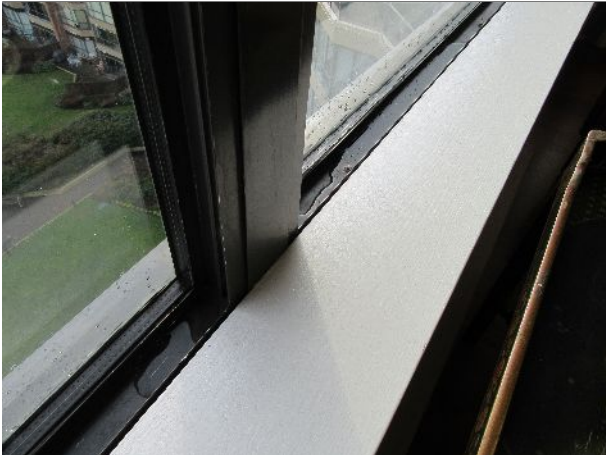
17 – Window leak in Unit 901 - 1470

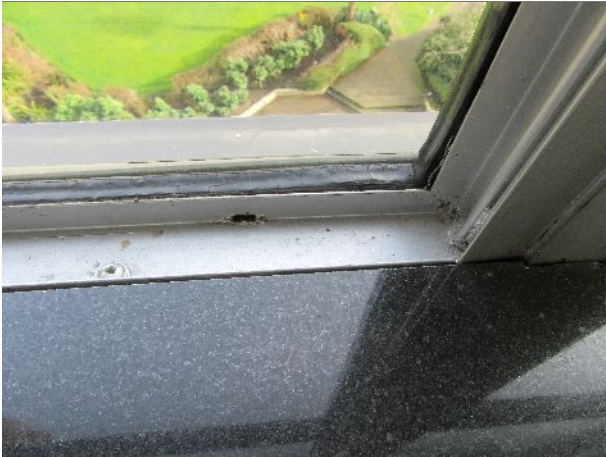
21 – IGU in 1470 building

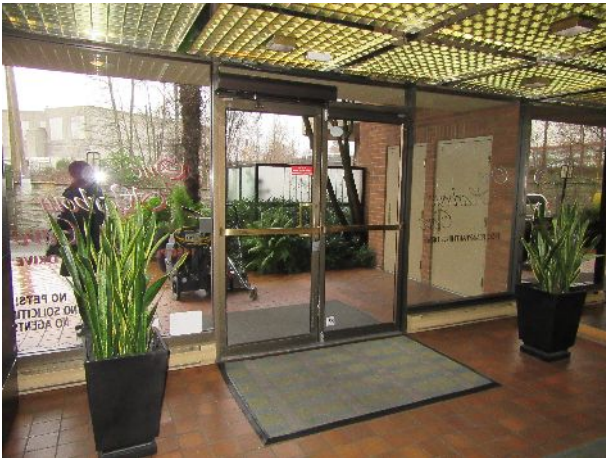
24 – 1450 main entrance doors

Occasional maintenance and replacement of door hardware, gaskets and weather-stripping will be required and should be replaced in a timely manner to avoid reducing the service life of the doors and frames. We expect that repair or replacement of the door hardware, gaskets and weather-stripping can be funded from the operating budget as required without significant impact.

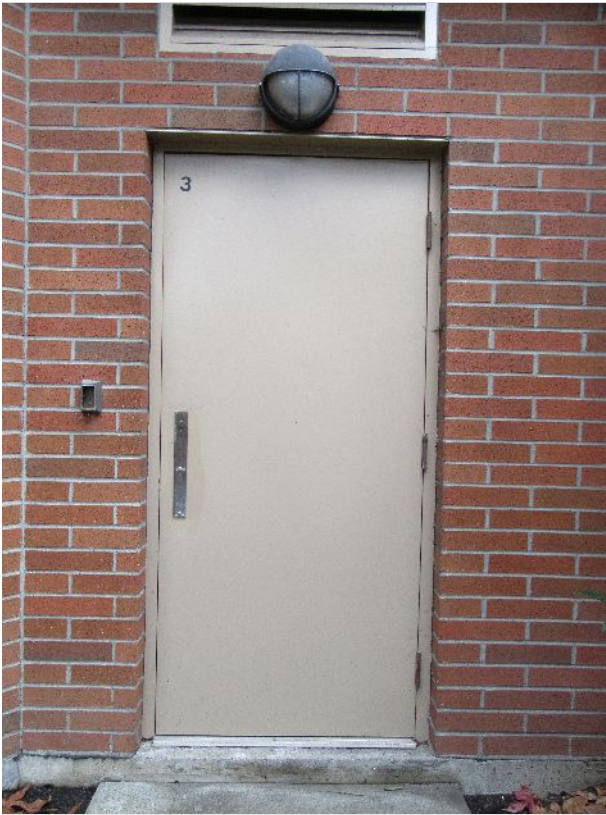
Some doors were missing door closers and some rooftop mechanical room doors could not close due to misalignment issues. Some of the door closers were not dampening the spring action of the door closers. We recommend that the building manager review all the metal doors of the complex and re-align the door leafs, install door closers where missing and adjust, repair or replace door closers that are not operating properly.

25 – Hollow metal exit door

Occasional maintenance and replacement of door hardware, door operators, gaskets and weather-stripping will be required and should be undertaken in a timely manner to avoid reducing the service life of the door leafs. We recommend that the doors and frames be re-painted approximately every five years to reduce the rate of corrosion. Based on the condition of the paint, we expect that the rooftop doors will require re-painting before the ground level doors. We believe that the funds for maintenance, repair and re-painting can be drawn from the operating budget as required without significant impact. If the doors are regularly maintained, repaired and re-painted, and not broken by forced entry, we do not expect that they will require replacement or significant repairs in the next 30 years.

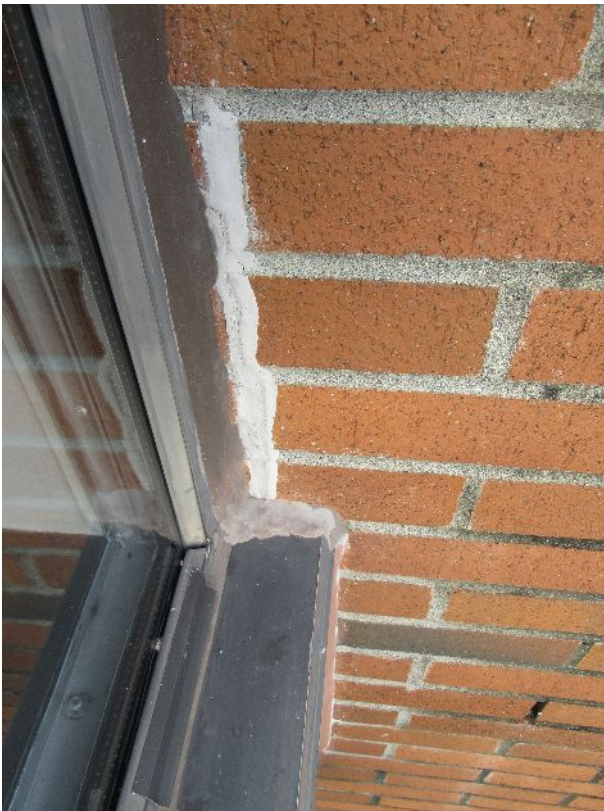
27 – Sealant at window-to-brick interface

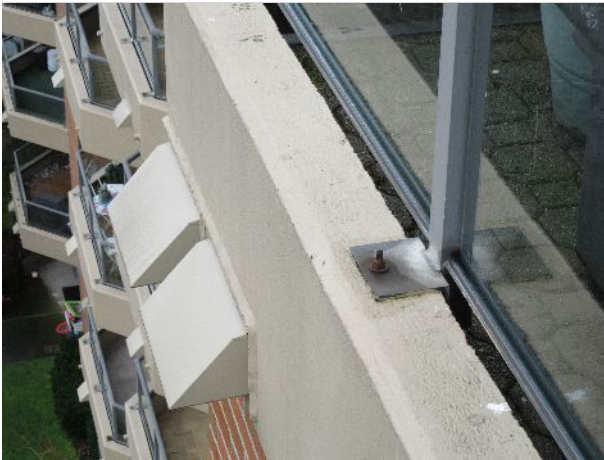
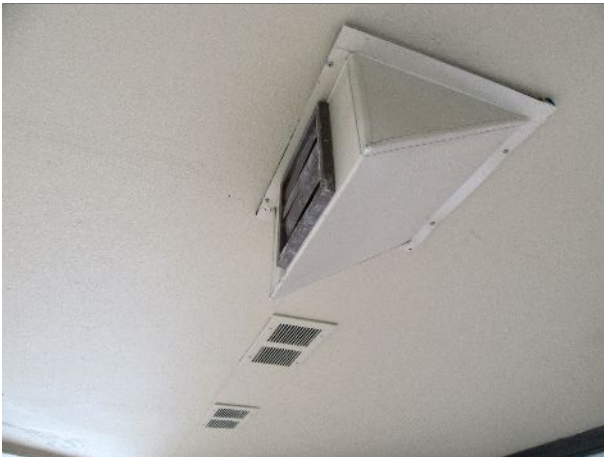
28 – Painted concrete upstand and vent hoods

29 – Painted balcony soffit

The present equivalent age represents the age of the paint applied during the first phase of the project. Future painting projects have been phased over four years based on the precedent set when the building was last painted. The budget is based on the actual costs of the last building re-painting project and includes painting of the original guardrails (not the rooftop guardrails) and replacement of approximately 50% of the sealants.

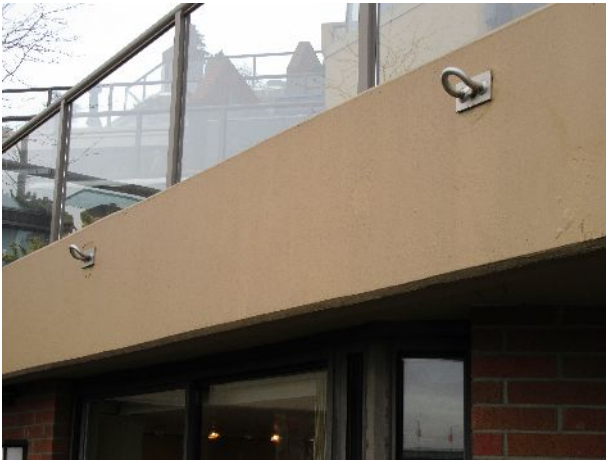
30 – Through-bolt anchors in concrete upstand

With regular maintenance and inspection, we do not expect that the suspended access system will require replacement or significant repairs in the next 30 years. A budget for annual inspections of the anchors (as required by WorkSafe BC) is not included in this report, because it is an annual expense which we expect is funded from the operating budget.

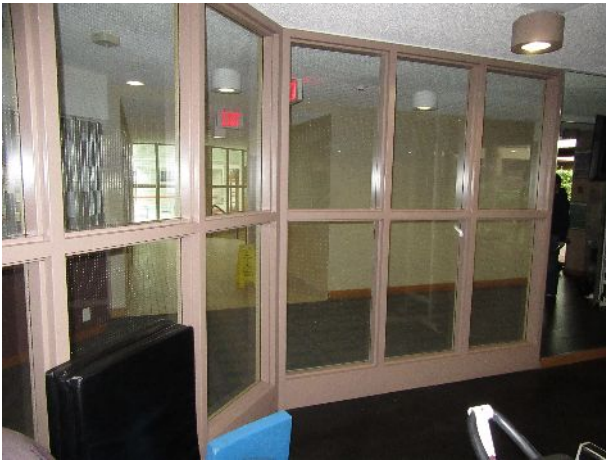
44 – Glazed interior partition at exercise room

A budget has been provided to remove the wall covering, spray-textured ceiling finish and ceiling feature finishes, paint the walls, steel framing and ceiling, and replace the light fixtures and electric baseboard heaters. We do not expect that the rubber flooring will require replacement in the next 30 years.

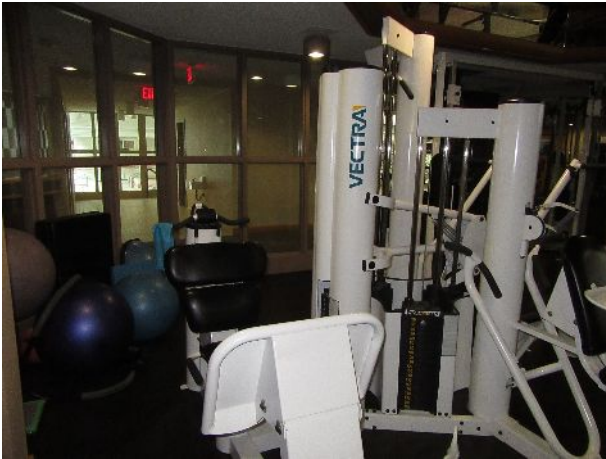
The strata corporation meeting minutes indicate that the exercise equipment is being leased. No budget has been provided for repairs or replacement given that this is typically the responsibility of the equipment provider.

46 – Exercise equipment in exercise room

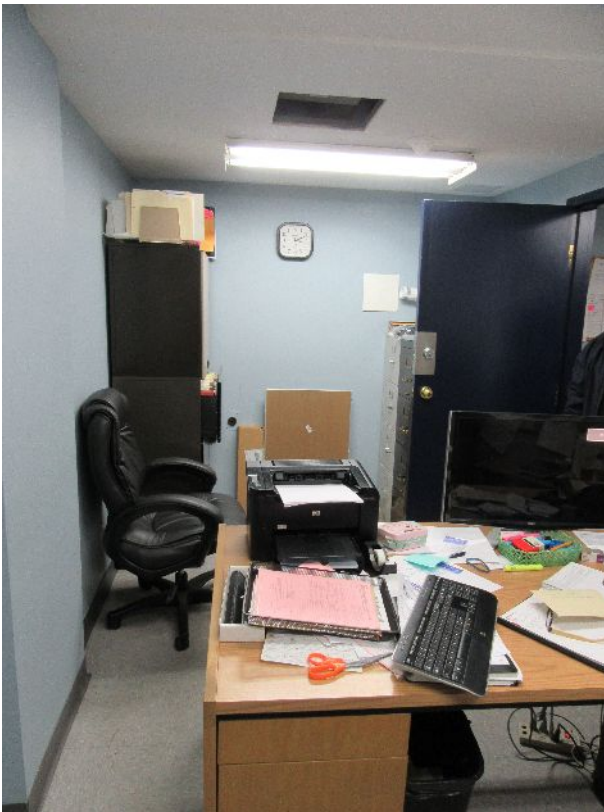
47 – Strata corporation office

A budget has been provided to renew the interior finishes of the office when we expect the vinyl tile flooring will require replacement. The budget includes replacement of the flooring and lighting, removal of the spray-textured ceiling finish, re-painting of the walls, replacement of the baseboard heaters and a furniture allowance of \$10,000. We expect that the funds required for occasional replacement of the furniture and equipment (including computer equipment) before and after the renewal project can be drawn from the operating budget as required.

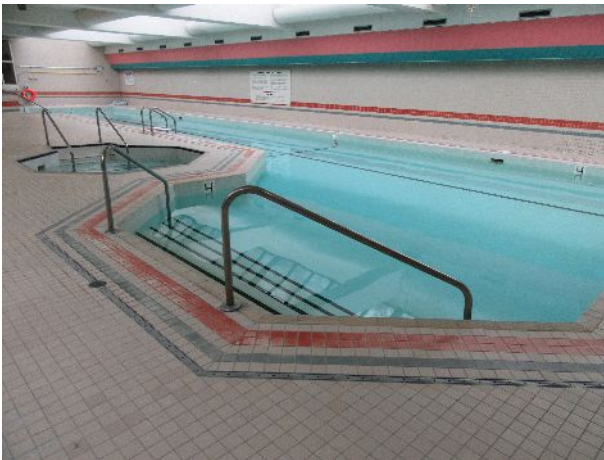
49 – Swimming pool area

A budget has been provided to replace the tile flooring and wall tile. Given that the floor of the recreation centre corridor adjacent to the pool area is also tiled and the two areas are visually interconnected, the budget also includes renewal of the interior finishes in this portion of the corridor. The budget includes re-painting of the pool area ceiling and glazed partition and the corridor walls and ceiling. A \$5,000 allowance for replacement of the pool furniture is also included in the budget.

A separate painting budget has been provided to re-paint the ceiling and steel framing of the glazed partition. A re-painting interval of ten years has been used for the pool area given the high humidity levels typical of natatoriums. If not already being done, we recommend re-sealing the tile flooring at five year intervals. This will reduce the likelihood that the tiles will delaminate from the concrete deck.

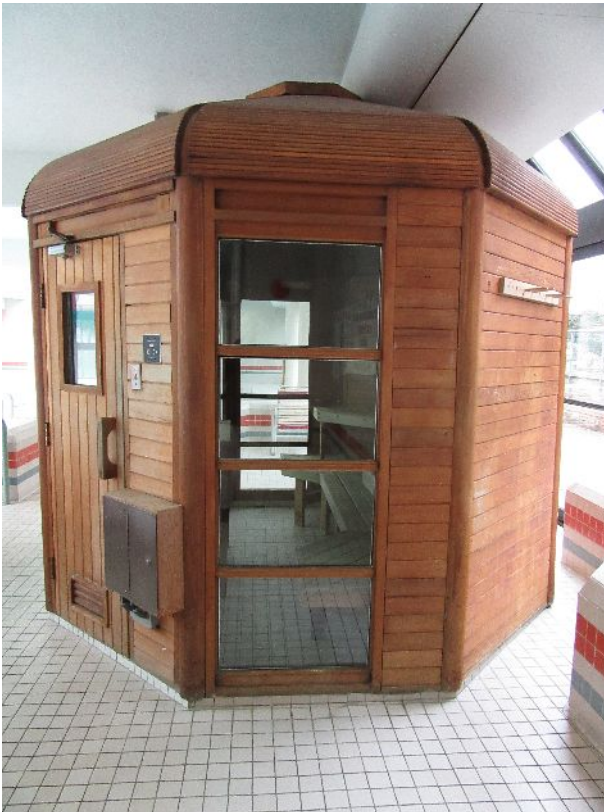
A free-standing dry sauna is located in the swimming area. Both the interior and exterior of the sauna walls and roof are finished in cedar. Some windows are installed in the sauna walls. The sauna was constructed over the swimming pool area deck; therefore the sauna flooring is identical to the swimming pool area's tiled flooring. The bench seating and heater enclosure appear to have been replaced since original construction.

50 – Sauna in pool area

A budget has been provided to replace the sauna when the tiling of the pool area is replaced. The budget includes the required plumbing and electrical work. We have not included replacement of the sauna heater in the sauna replacement budget given that it was recently replaced and will likely be able to provide many more years of service when the sauna will be replaced.

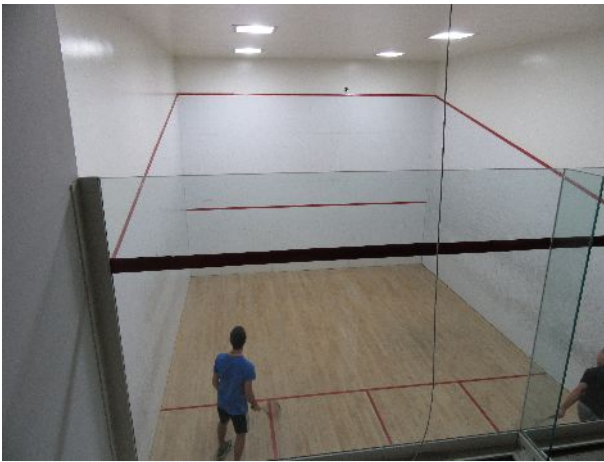
53 – Squash court

A budget has been provided to replace the hardwood flooring and high density walls, and to re-paint the walls and ceilings of the squash court. Given the less frequent use of the racquetball court, we do not expect that the interior finishes of the racquetball court will require replacement in the next 30 years. We expect that the funds required to re-sand the floors and paint the walls and ceilings of the two courts can be drawn from the operating budget as required.

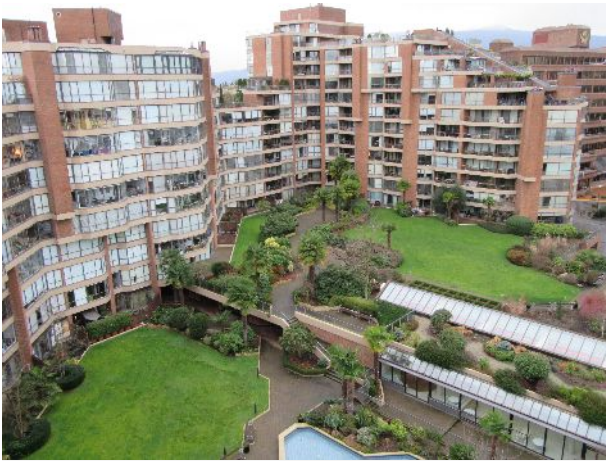
Although the components and soft landscaping which make up the exterior grounds could last significantly longer, the expected service life value is based on the expected service life of the waterproofing membrane below it given that the exterior grounds will have to be removed to replace it. As such, we do not recommend that the owners undertake major projects in this part of the courtyard. We expect that small projects such as re-painting the retaining walls or privacy screens, can be funded from the operating budget without significant impact. The budget to replace the hard and soft landscaping elements above the waterproofing membrane is included in the PKD.1 plaza slab waterproofing membrane replacement budget.

56 – Exterior grounds over waterproofing membrane

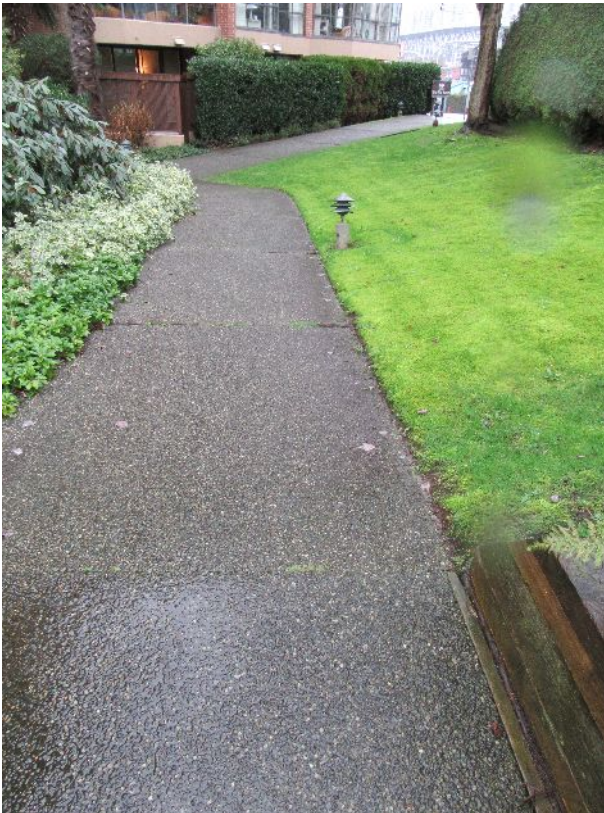
No significant cracks or differential settlement were observed in the concrete walkways, sidewalks and steps. The service life of concrete walkways and sidewalks varies depending on the integrity of the compacted base below the concrete panels and how quickly cracks are sealed. The estimated remaining service life relates to the walkways and sidewalks not located over a waterproofing membrane. The concrete walkways above the parkades and leisure centre will require replacement during the parkade waterproofing replacement project.

59 – Walkway in south courtyard

We recommend that the owners address differential settlement when a step between adjacent panels exceeds 1/2". The step can be eliminated by grinding a taper into the elevated panel. We expect that crack sealing, grinding and re-painting of the sidewalks can be undertaken with funds from the operating budget as required.

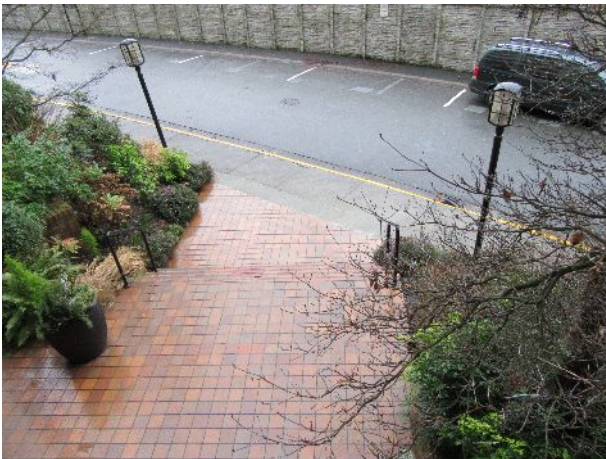
The service life represents that of porcelain tile exposed to precipitation. The present equivalent age represents the age of the tile at the 1450 and 1470 entrances. Some cracked and delaminated tiles were observed at the 1470 entrance, likely due to settlement. A replacement budget has been provided for the tile at these two entrances. We do not expect that the 1490 tile or the painted steel handrails at the 1450 entrance will require replacement in the next 30 years.

60 – Tiled walkway at 1450 entrance

The owners should consider applying a tile and grout sealer at regular intervals to reduce the moisture absorption rate of the tile and grout. This would help reduce the likelihood of delamination, particularly for the tile which is more exposed to precipitation.

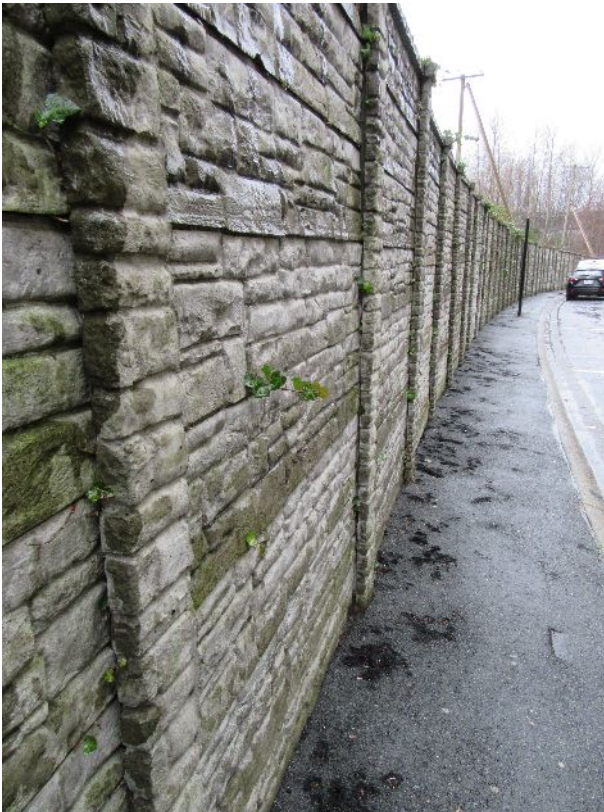
The strata corporation meeting minutes indicate that two sections of the fence were replaced in 2011 and one section was replaced in 2015. The posts appeared to be reasonably plumb. Based on the rate of deterioration of the fence since original construction and assuming that settlement will not seriously affect the fence, we do not expect that the fence will require full replacement in the next 30 years. We believe that some sections or fence posts may require replacement in the next 30 years, but we expect that the funds for occasional repairs and maintenance can be drawn from the operating budget as required.

62 – Precast concrete fence

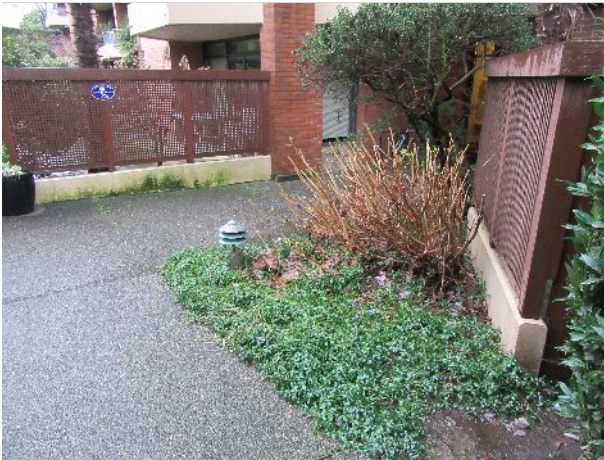
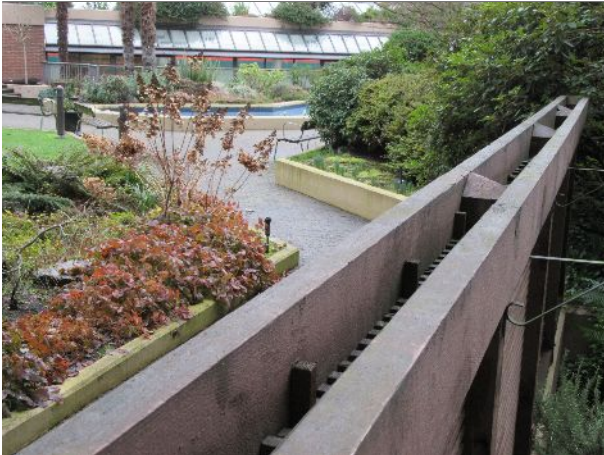
63 – Patio enclosure adjacent to Co-op housing entrance

64 – Top rails of patio enclosure

For aesthetic reasons, a budget has been provided to stain the wood enclosure and privacy screens every five years with a high quality solid stain. Given that the wood benches in the courtyards need to be stained at more or less the same interval, staining of the wood benches is also included in the budget. Based on the condition of the finish, we expect that the next occurrence will be in approximately three years.

When wood enclosure replacement is undertaken, the owners could consider installing aluminum enclosures and privacy screens which have a significantly longer service life than wood and much lower maintenance costs. To extend the service life of the wood enclosure (not located over the parkade), we recommend installing a sloped wood cap over the top rails of the fencing and privacy screens.

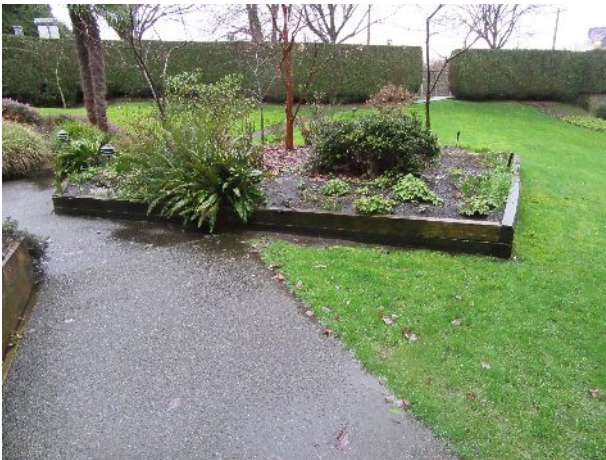
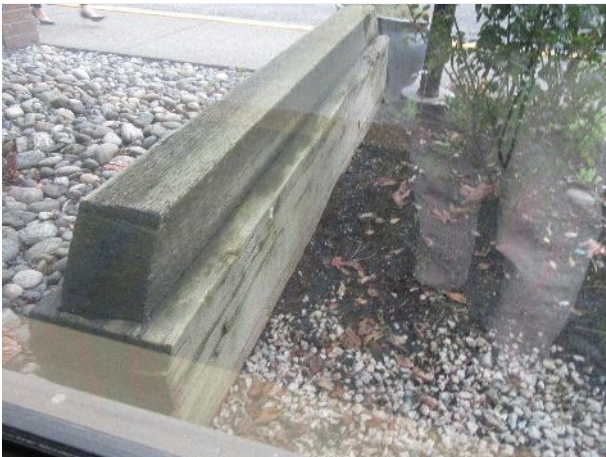
The expected service life represents an average service life. The actual service life of each retaining wall varies considerably based on installation, exposure to precipitation and sunlight, exposure to sprinkler head spray and the surrounding plantings. We expect that the operating budget will be used to fund localized replacement of the wood retaining walls (not located over a waterproofing membrane) as required.

68 – Wood retaining walls at south courtyard

69 – Wood retaining wall on west elevation

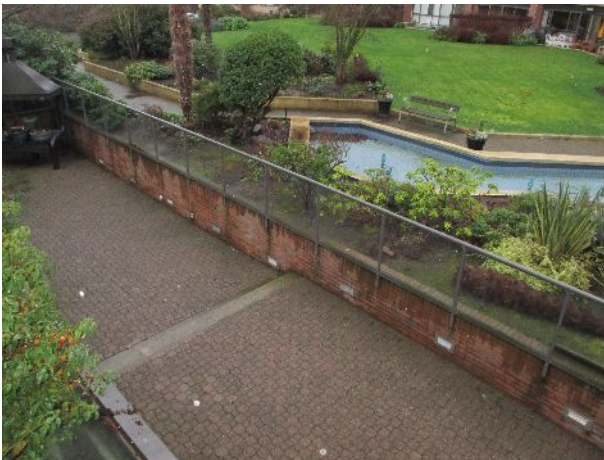
70 – Brick retaining wall at lower courtyard

A budget has been provided to replace the brick retaining walls not located over the parkade and leisure centre with more durable cast-in-place concrete retaining walls. The budget to replace the brick retaining walls located over the parkades and leisure centre is included in the parkade waterproofing membrane replacement project.

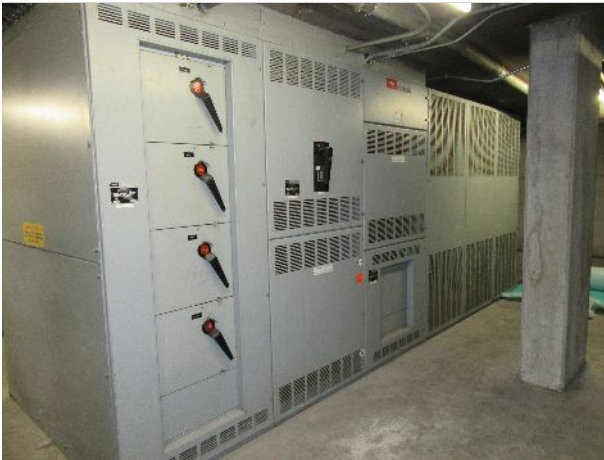
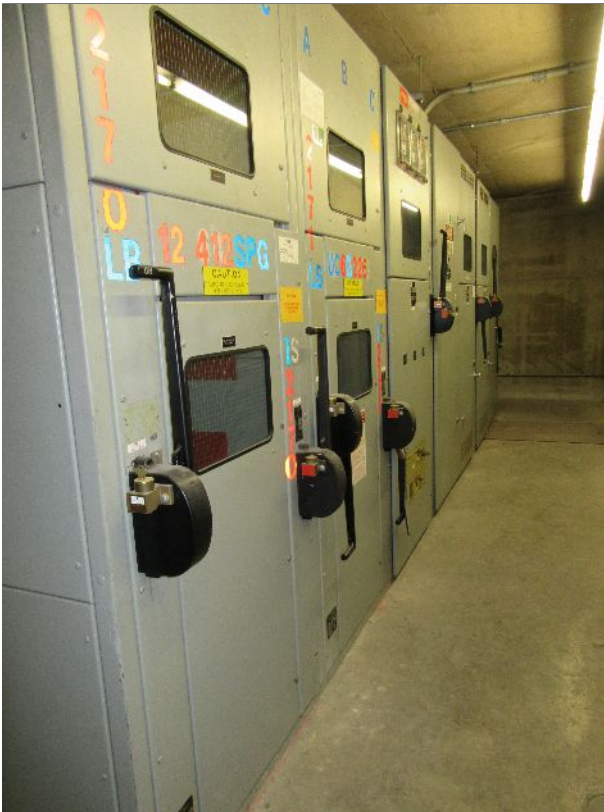
The expected service life for the unit substations represents that of the transformer and switchgear unit within the unit substations and not that of the entire unit substation. A repair budget has been provided for transformer and switchgear unit replacement in the four unit substations. Although the owners could choose to use the accrued funds to replace unit substation components as they fail, a proactive replacement strategy would significantly minimize down time given that unit substation components may take weeks or months to acquire. We do not expect that the unit substations will require complete replacement in the next 30 years.

Service stickers indicate that the dual radial unit substation was last serviced in 2013. BC Hydro requires that dual radial unit substations be maintained at three year intervals. A maintenance budget has been provided for this maintenance.

73 - 1470 unit substation

74 - Dual radial unit substation

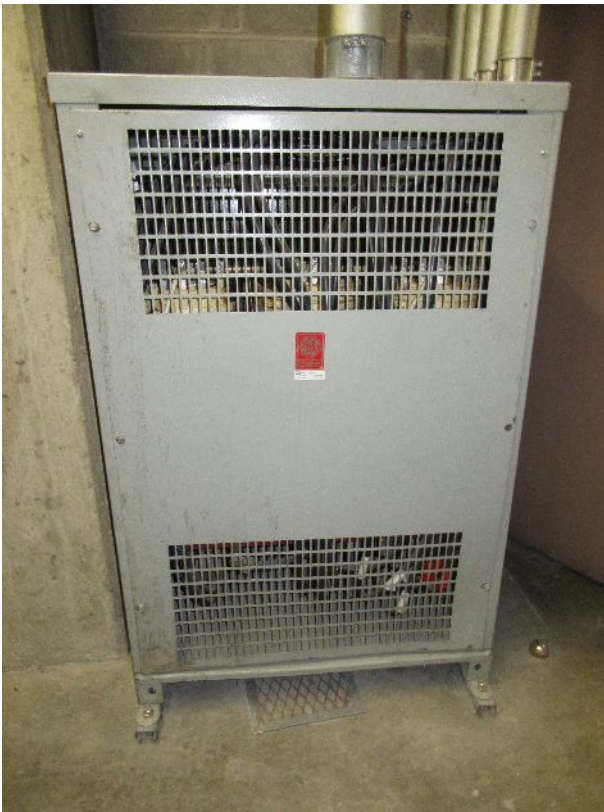
Over time dielectric and insulation materials will break down making it necessary to replace the transformer. A replacement budget has been provided to replace all the transformers with the exception of the emergency transformer in the generator room and the transformers in the elevator machine rooms which we believe were replaced during the recent elevator modernization projects. Although the owners could choose to use the accrued funds to replace transformers as they fail, a proactive replacement strategy would significantly minimize down time given that transformers may take days or weeks to acquire. We recommend that replacement transformers incorporate a base which elevates them off the ground (or be installed on concrete pads).

75 – Dry type transformer installed in electrical room

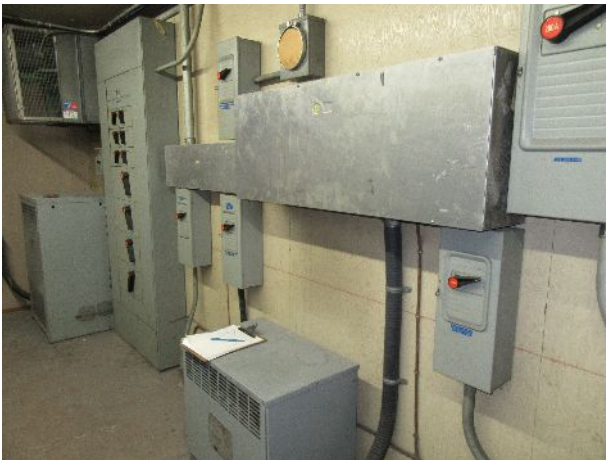
The expected service life and condition assessment represent an average service life and condition of the major components which make up the electrical distribution system. We expect that some of the components will require replacement in approximately 20 to 30 years. A budget has been provided to replace some electrical distribution equipment beginning in the 2039/2040 fiscal year. A recurrence interval of five years has been applied to the replacement budget to allow for gradual replacement of the majority of the electrical equipment. We expect that smaller electrical components such as small disconnect switches, contactors, light switches and receptacles can be replaced with funds from the operating budget as required. We do not expect that the electrical wiring will require replacement or major repairs in the next 30 years.

76 – Electrical equipment in 1490 electrical room

We recommend that an infrared scan of the electrical equipment be done if it has not been done in the last ten years. Infrared scanning of the distribution panels, disconnect switches and panelboards should be undertaken approximately every ten years to identify loose, over-torqued, dirty or overloaded connections.

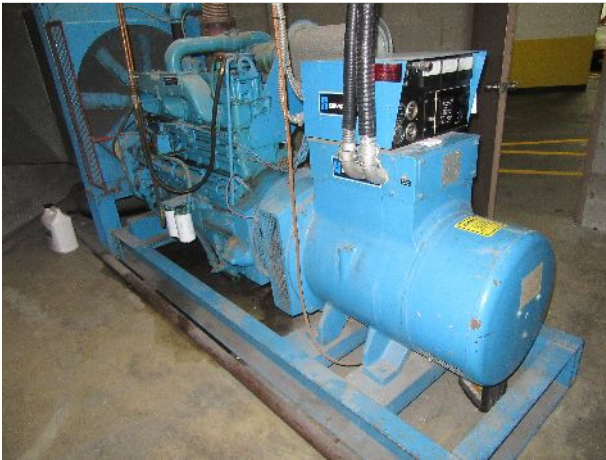
A 275 kW diesel-powered Simpover standby generator is installed in the generator room next to the 1470 electrical vault. It produces 600 V power which is stepped down to 120/208 V by a transformer located in the generator room. We assume that the generator dates from original construction. The strata corporation meeting minutes indicate that some major repairs were done to the generator in 2013. The emergency electrical supply is distributed to a variety of electrical loads including indoor lighting, the 1470 elevators, parkade lighting, parkade gate operators, stairwell pressurization fans, sump pumps, parkade exhaust fans and corridor pressurization fans.

77 – Diesel-powered generator

The strata corporation meeting minutes indicate that annual generator inspection, maintenance and testing is taking place as required by the BC Fire Code. A maintenance budget has been provided for five-year (quinquennial) maintenance as stipulated in the related standard CSA C282. The last five years of meeting minutes do not document whether this five-year maintenance has been performed; therefore, we have assumed that it has not been done in the last five years and scheduled it for the first year of the report's projection period. A replacement budget has been provided to replace the generator at a point in time when we believe it will become too difficult or expensive to source replacement parts. We expect that the occasional repairs to the generator can be funded from the operating budget.

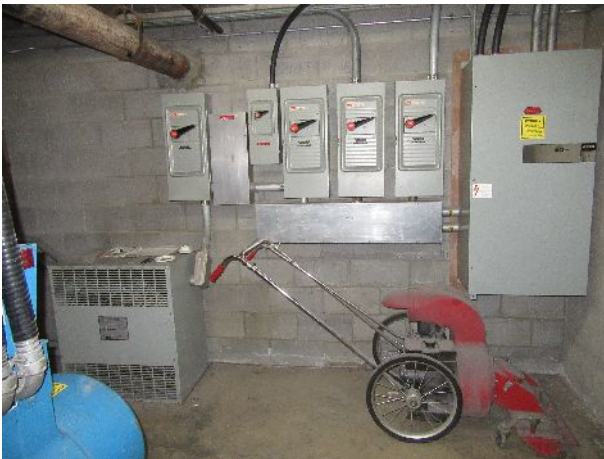
The expected service life represents that of the ATS. A budget has been provided for replacement of the ATS. We do not expect that 600 V disconnect switches, transformer and panelboards will require replacement in the next 30 years.

78 – Emergency power distribution equipment

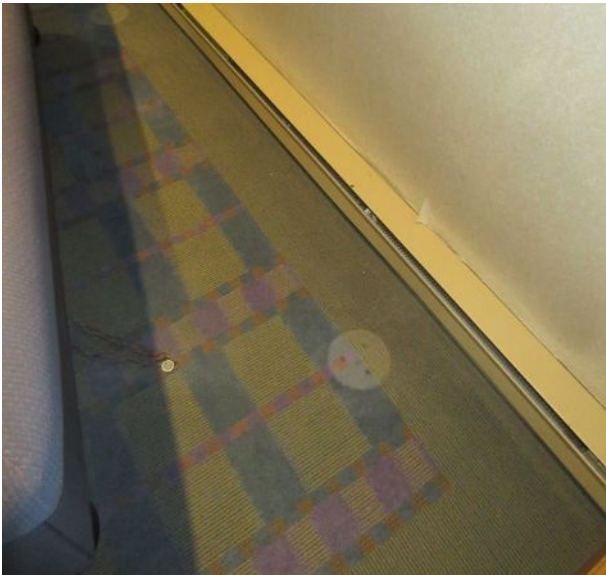
The integral thermostat dials on some of the baseboard heaters did not appear to be working. A budget has been provided to replace the baseboard heaters in the corridors under the windows. For aesthetic reasons, we expect all of these baseboards to be replaced at the same time. The estimated remaining service life for the baseboard heaters has been overridden so that they are replaced at the same time as the corridor renewal project. This will ensure that the new interior finishes can be properly installed around the new baseboard heaters. If the owners are considering changing the timing of the corridor renewal project, we recommend that the timing for the replacement of the baseboard heaters be done adjusted correspondingly.

79 – Electric baseboard heater in entrance lobby

The budgets to replace the electric baseboards in the main entrances, change rooms, meeting room, library and exercise room are included in the renewal project budgets for the respective areas. We expect that the remaining standalone baseboards will be replaced as they fail with funds from the operating budget.

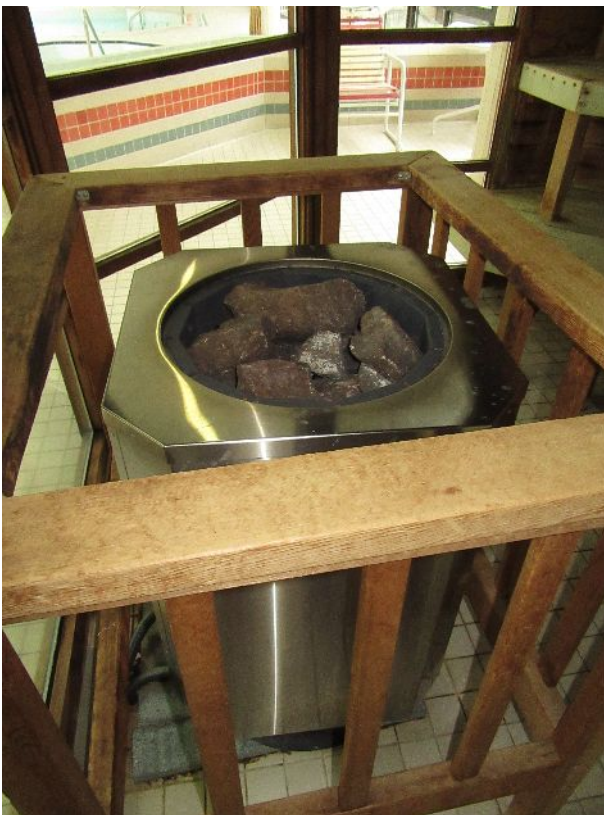
The dry sauna, located in the swimming pool area, is equipped with a dry sauna heater. The strata corporation meeting minutes indicate that it was replaced in 2011.

80 – Sauna heater

A budget has been provided for replacement of the dry sauna heater.

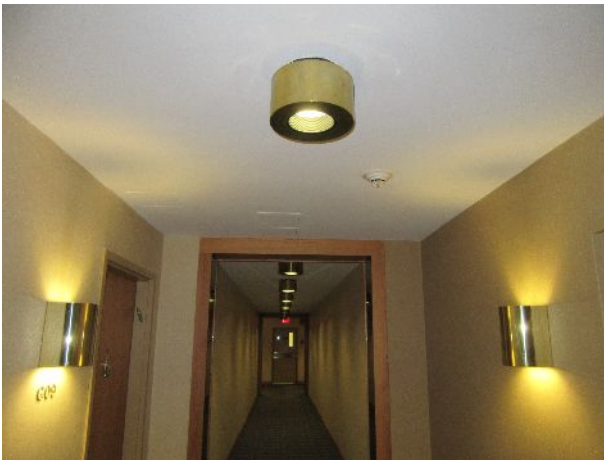
The expected service life, present equivalent age and condition assessment relate to the stairwell lighting only. With the exception of stairwell lighting, most common area light fixtures are typically replaced when modernizing the interior finishes.

81 – Corridor lighting

A budget has been provided to replace the light fixtures in the stairwells to more energy efficient lighting (LED) when the ballasts in the light fixtures fail. Until this replacement project, we believe that the replacement of failed fluorescent strip light fixtures can be funded from the operating budget as required. We do not expect that the owners will choose to modernize the light fixtures in the service rooms, parkade elevator lobbies, squash court and racquetball court in the next 30 years. The budget to replace the remaining common area interior lighting is included in the budget to renew the interior finishes of the respective areas.

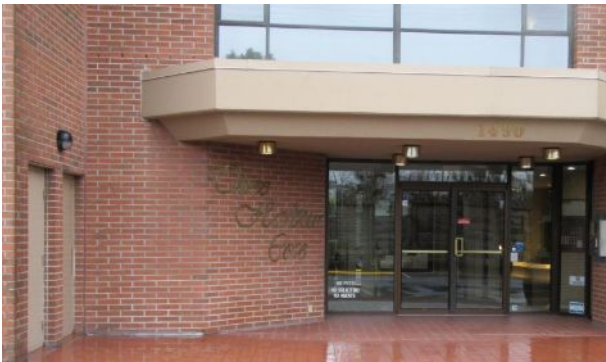
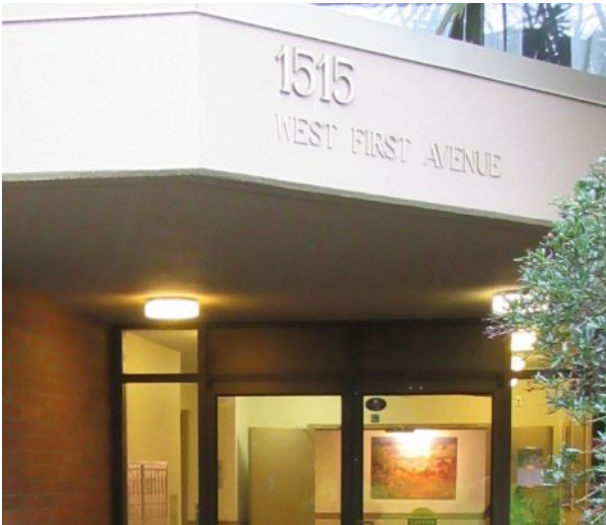
The expected service life represents an average modernization interval for exterior lighting in residential complexes. This interval is mostly dependent on the demographic profile of the owners and the market appeal of the complex. In reality, light fixtures can last significantly longer than the modernization interval, in particular the light fixtures which are sheltered from precipitation. The present equivalent age and condition assessment represent the average age and condition of the soffit-mounted and wall-mounted light fixtures. A budget has been provided to replace the common exterior light fixtures. We assume that the exterior light fixtures which illuminate the limited common property (patios and roof decks) are the responsibility of each owner.

82 – Soffit and wall light fixtures

83 – Soffit-mounted entrance lights

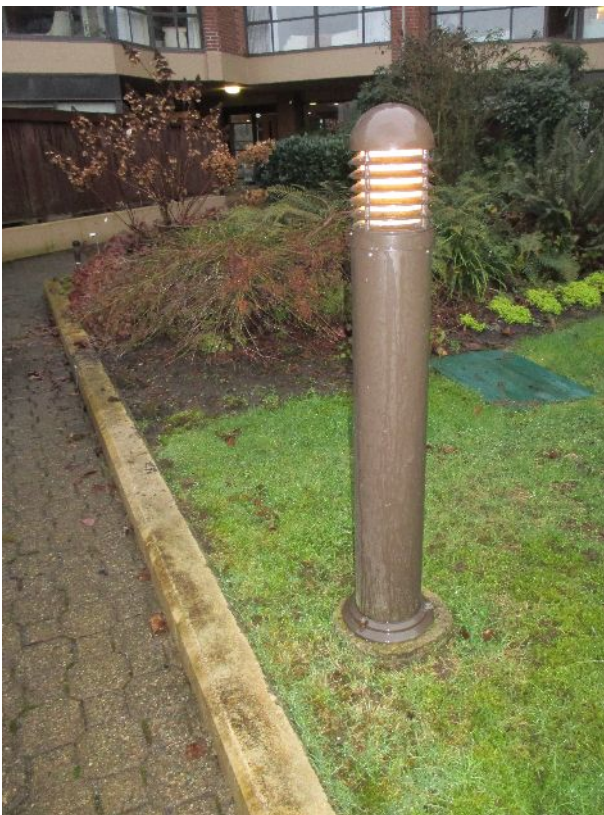
The service life, present equivalent age and condition assessment represent an average service life, age and condition for the four types of walkway light fixtures. A budget has been provided to replace the courtyard lighting throughout the complex's exterior grounds. It does not include replacement of the associated electrical wiring. We have assumed that the walkway lighting will be removed and reinstated during the parkade waterproofing replacement project described in PKD.1.

84 – Bollard light in courtyard

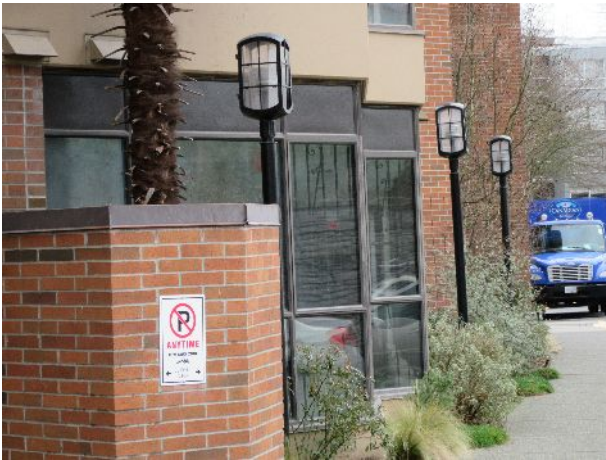
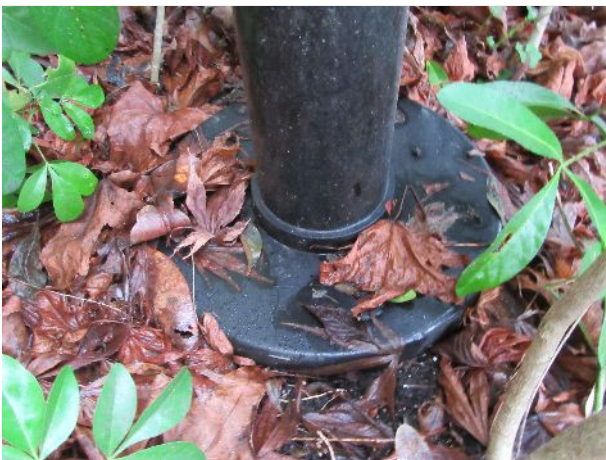
85 – Lamp post lighting along Pennyfarthing Drive

86 – Lamp post base

We recommend that the fasteners securing the lamp post to the concrete base be reviewed annually for signs of corrosion and replaced when corrosion is observed. As the light is subject to wind loading, we also recommend that the metal base of the light be reviewed annually for cracks. The light fixtures should be painted approximately every five years. We expect that the funds required for repainting can be drawn from the operating budget as required without significant impact.

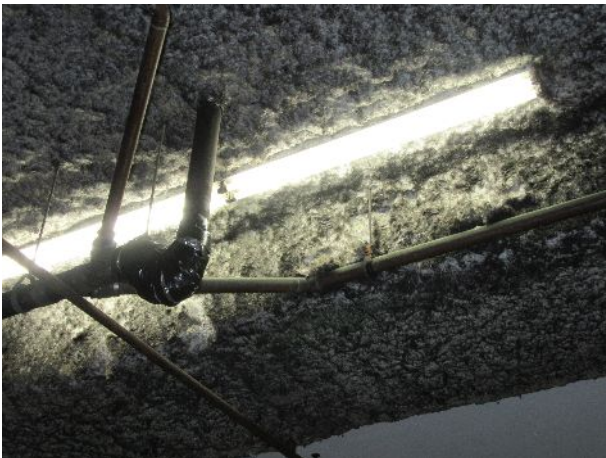
The service life relates to the ballasts in the T8 light fixtures. The replacement budget includes replacement of the T8 lighting with LED lighting. Until the light fixtures are replaced, we expect that the required funds for replacement of ballasts (which fail before the replacement project) can be drawn from the operating budget as required.

87 – T8 fluorescent strip light in parkade

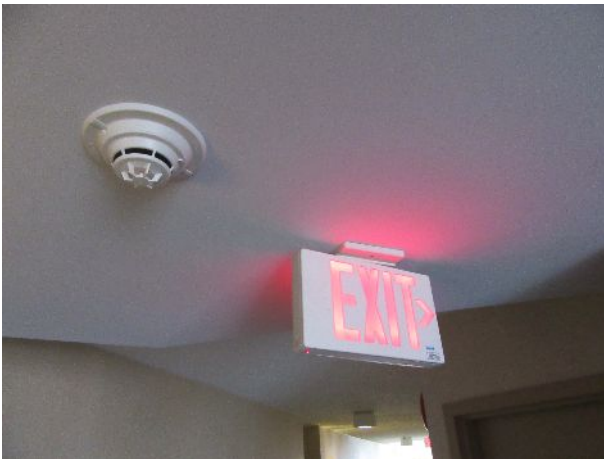
We do not expect that the exit signs will be replaced in the next 30 years due to aesthetic or functional concerns. We expect that spent light bulbs and back-up batteries will be replaced as required after the annual BC Fire Code inspection with funds from the operating budget.

88 – Plastic emergency exit signage

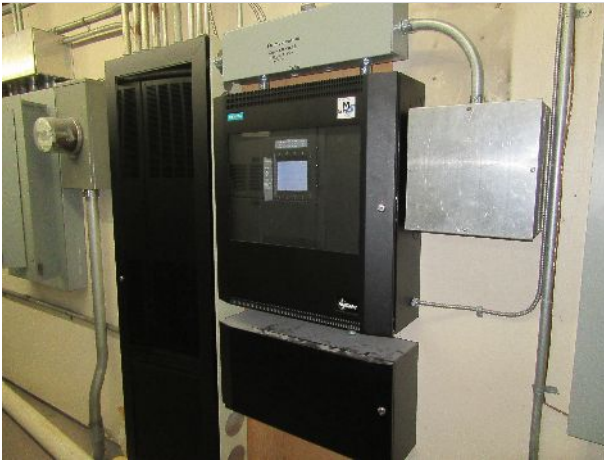
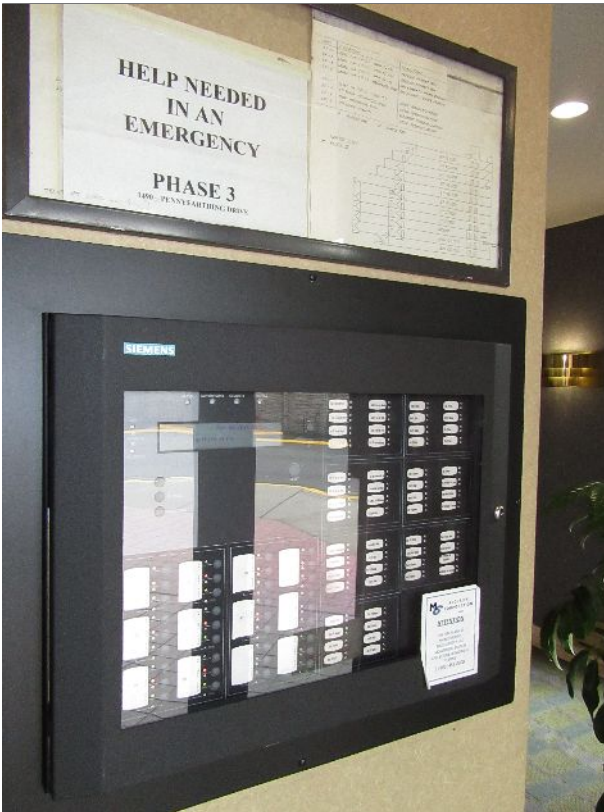
The expected service life represents the point in time which we believe replacement parts for the fire alarm control panels and annunciators will become problematic to find. This is likely to occur because manufacturers often phase out production of the replacement parts and most fire protection service providers are reluctant to utilize used components for repairs. The present equivalent age and condition assessment is an average of the three fire alarm panels and annunciators which were replaced between 2012 and 2014.

89 – Siemens FireFinder XLS fire alarm control panel

90 – Siemens annunciator panel in 1490 building

A budget has been provided to replace the annunciator panels in the lobbies and the fire alarm control panels in the electrical rooms. The budget does not include replacement of wiring, notification appliances or initiation devices. We expect that the operating budget is used to fund the required replacement of deficient initiation devices, notification appliances and other fire alarm system components after each annual BC Fire Code inspection. When renovating the corridors, we suggest that the owners consider lowering the manual pull stations to the height stipulated in the current building code.

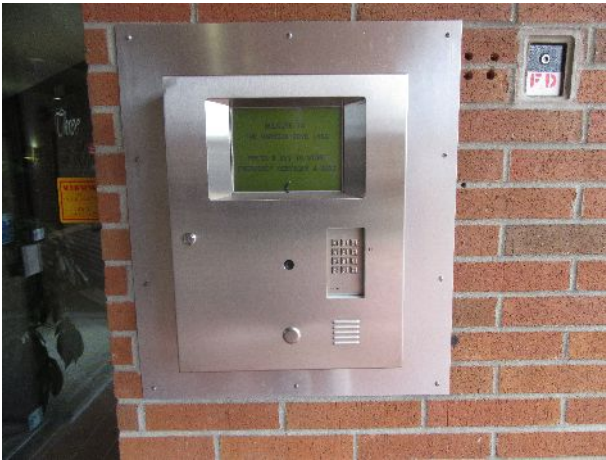
Most telephone entry system replacement parts become increasingly difficult to source as manufacturers phase out production of the parts and subsequent inventories of new and used parts are depleted. This will mean that in the future, an otherwise minor repair may become a full replacement instead. The replacement budget includes both the entry panel and control panel, but does not include replacement of the wiring.

91 – 1490 telephone entry system panel
