# Harbour Cove Depreciation Report

1450, 1470 & 1490 Pennyfarthing Drive, Vancouver, BC

Draft Report: August 10, 2016

Final Report: May 2, 2017

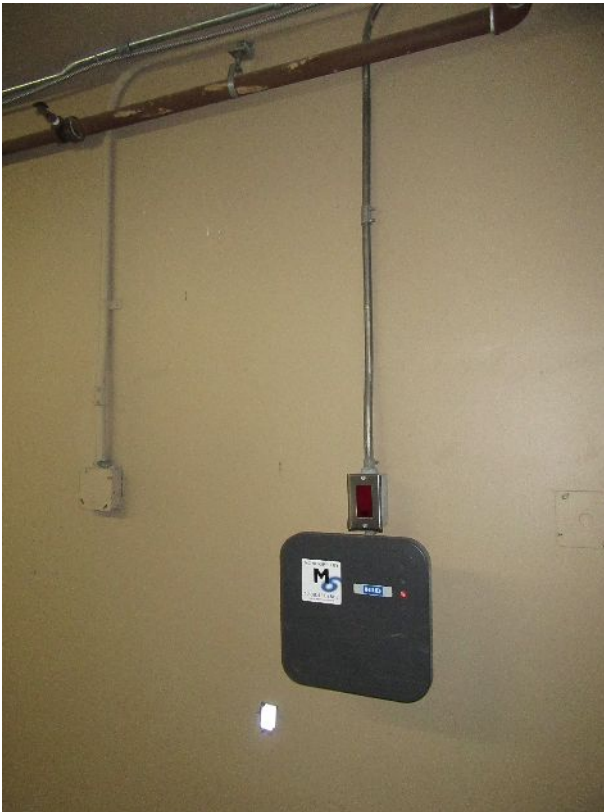
92 – Card reader in parkade

A budget has provided to replace the card readers and control panels throughout the complex at a point in time when we expect new and used replacement parts will be difficult to find. The replacement budget is based on the estimate to replace the system in 2014 (without entering into a five-year monitoring contract). We expect that the replacement of electric strikes and upgrading of the software can be funded by the operating budget as required.

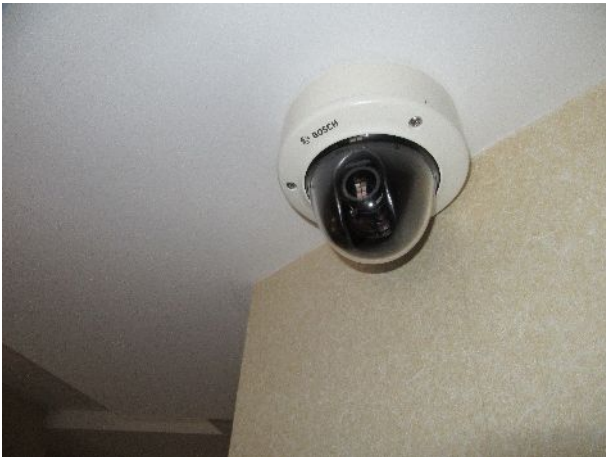
The expected service life represents the service life of the cameras. A replacement budget has been provided to replace the system, excluding the camera wiring. The video recorder and monitor have a shorter service life than the cameras, but we expect that they will be replaced as required with funds from the operating budget. The service life does not take into account the adequacy of the system. Upgrading the system is a discretionary decision and therefore is not included in this report.

93 – Camera at 1470 entrance lobby

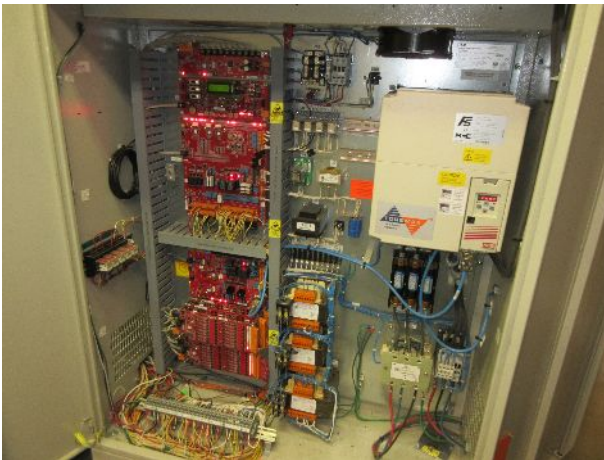
These elevators were modernized with new solid state microprocessor controls as well as AC variable frequency drives. These controllers require less maintenance than the relay type and provide improved reliability, trouble-shooting capability, and adjustability. The controllers do not contain technology proprietary to City Elevator and may be maintained by other contractors.  
 The elevators appeared to be in good operation; the leveling and ride quality are considered good.  
 Budget for modernization is \$350,000.00 per building (\$1050,000.00 total).

94 – Controller

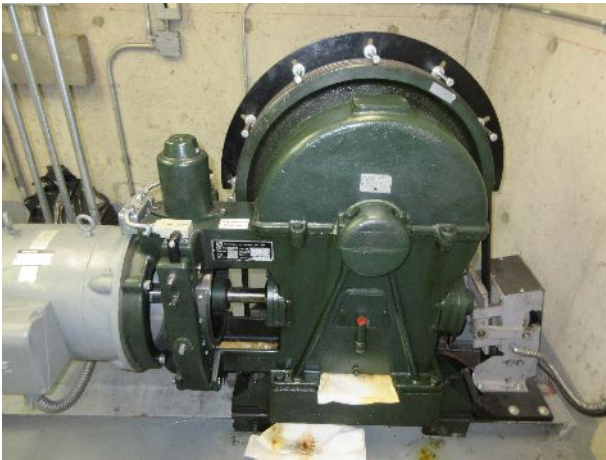
The Northern and Dover machines are of a fair design and are original to the installation. Replacement as part of the next modernization will be required.

95 – Machine

Budget for the machines are \$90,000.00 per building (\$270,000.00 total).

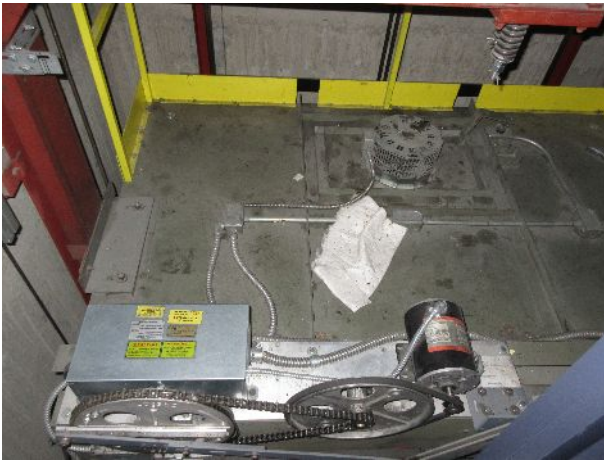
96 – Door Operator

Door Operator: \$17,500.00 per elevator  
Door Detector: \$2,500.00 per elevator

This budget has been included under the modernization cost (ELEV.1 - Controllers and Drives)

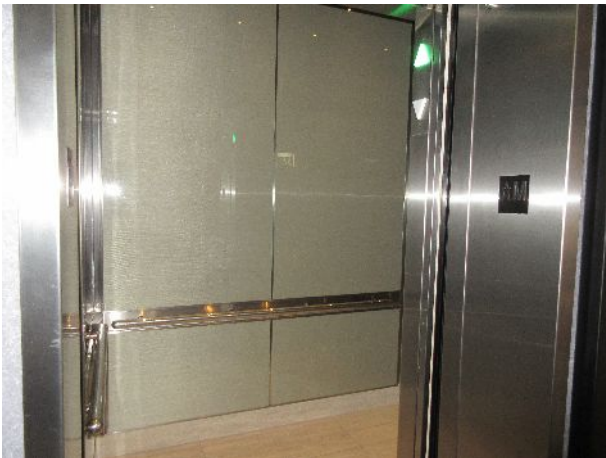
The cab finishes are in good condition, any upgrade to the cab finishes is at the discretion of the Owner. The cab interiors are stretcher accessible.

97 – Cab Interior

Budget for this work is \$50,000.00 per building (\$150,000.00 total).

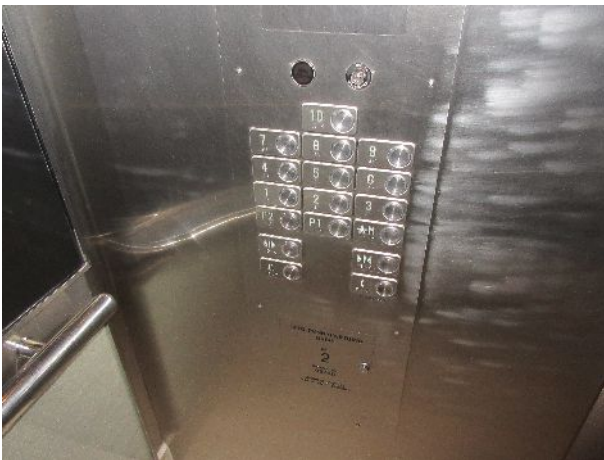
The operating fixtures are vandal resistant, in good condition, replaced with the modernization, and meet all requirements for disabled persons access. The mandatory requirement for emergency communication is in place. All operating fixtures will be included in a controller and drive modernization. The cost is included under ELEV.1 - Controllers and Drives.

98 – Car Operating Panel

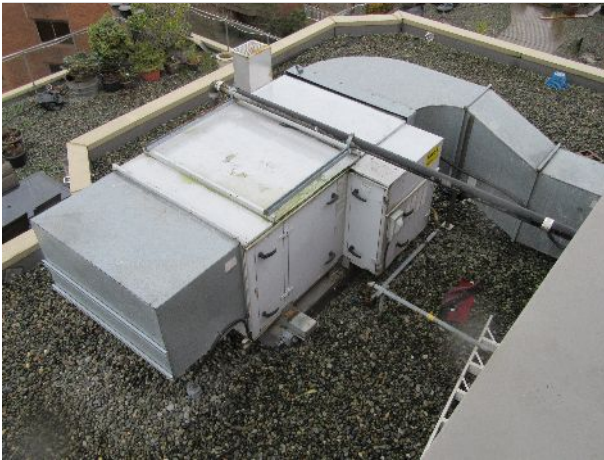
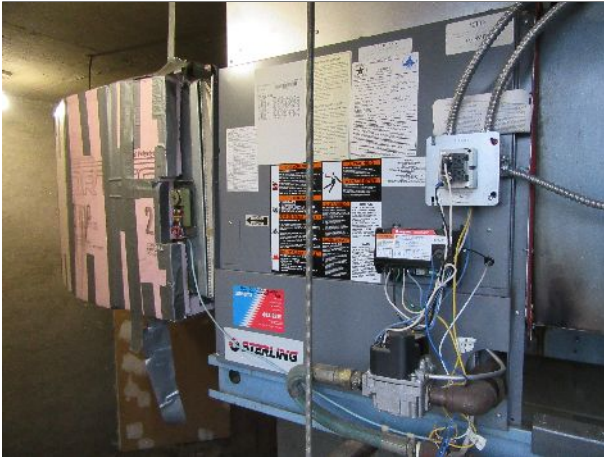
The expected service life and present equivalent age represent the average service life and estimated age of the 1450 AHU and the major components of the other two AHUs. A budget has been provided to replace the 1450 AHU and the major components (duct furnaces, blowers, etc.) of the other two fans in the 2030/2031 fiscal year, assuming that the major components of the 1470 and 1490 AHUs were replaced within a few years of when the 1450 AHU was installed (2006). Although smaller AHU components (fan belts, pulleys, bearings, etc.) may require replacement before the AHUs are replaced, a budget has not been provided for these smaller repair projects because we believe that the funds for the repairs can be drawn from the operating budget as required without significant impact. We do not expect that the ducting or supply grilles will require replacement or significant repairs in the next 30 years.

99 – 1450 AHU

100 – 1490 AHU inside mechanical room

We recommend that the ducting for the supply fans be cleaned approximately every five years. A maintenance budget has been provided for this. The strata corporation meeting minutes indicate that the ducting was last cleaned in 2013, therefore the next cleaning has been scheduled to occur in the 2017/2018 fiscal year.

We also recommend that the supply fan for the 1450 ground floor corridor runs continuously. By pressurizing the corridors, smoke generated by a fire inside a unit will not spread into the corridor. If the air is too cool for the occupants, the owners should investigate whether it is possible to supply warm air from the 1450 rooftop AHU.

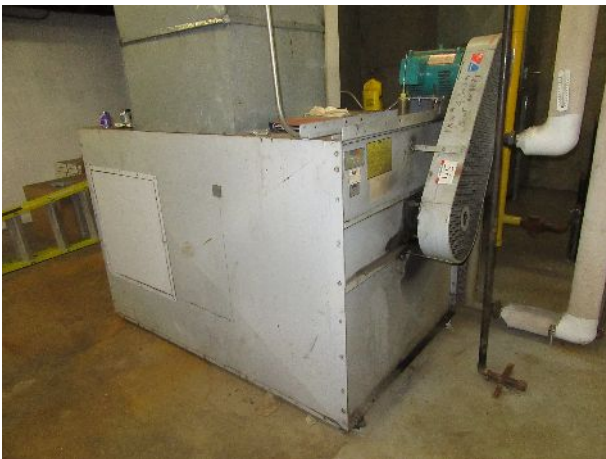
101 – Swimming area AHU

Given that the AHU is located indoors, we do not expect that full replacement will be required in the next 30 years. A repair budget has been provided to replace the heating copper heating coil. We assume that the heating coil has not been replaced since original construction, but the other internal components of the AHU have been replaced since original construction. We expect that occasional replacement of or repairs to the dampers, damper actuators, blower, blower motor, circulation pump and expansion tank can be funded from the operating budget without significant impact. The budget to replace the boiler and copper piping is provided in the Swimming Pool - Water Heater component.

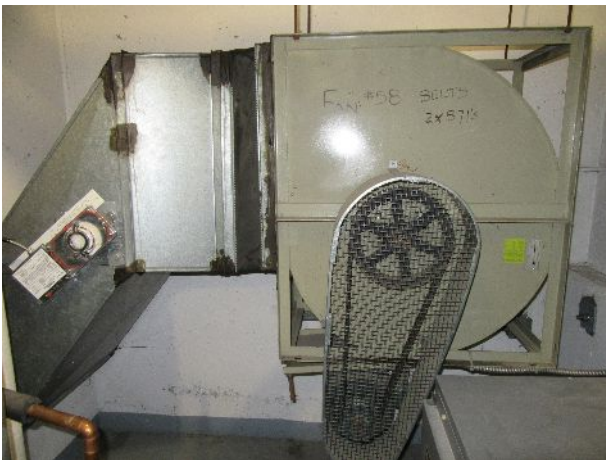
102 – Stairwell pressurization fan

Because the fans are located indoors, we do not expect that they will require full replacement in the next 30 years if motors and belts are replaced as required. Instead, we expect that the funds for occasional repairs or component replacement can be drawn from the operating budget as required without significant impact. We do not expect that the supply grilles in the stairwells and elevator shafts, or the ducting between the fans and the supply grilles, will require replacement or significant repairs in the next 30 years. If not already being done during the annual inspections mandated by the BC Fire Code, we recommend that the fans be run annually to confirm that they are fully operational.

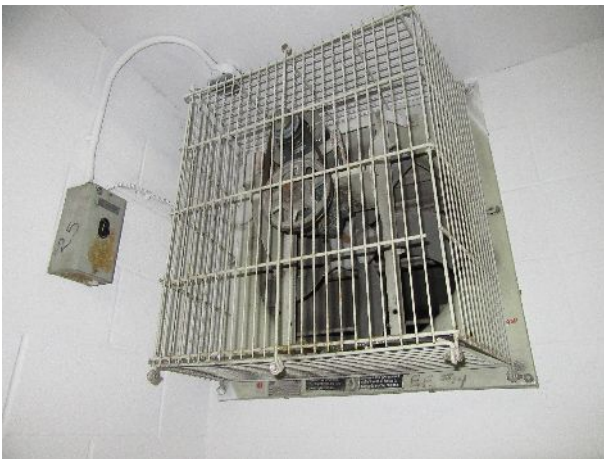
Because the fans are located indoors, we do not expect that they will require full replacement in the next 30 years if motors and belts are replaced as required. Instead, we expect that the funds for occasional repairs or component replacement (fan motors, propellers, etc.) can be drawn from the operating budget as required without significant impact. The exhaust fans should be reviewed and serviced by a qualified mechanical maintenance service provider at least annually.

103 – Parkade exhaust fan

Although not mandatory, we recommend installing hazardous gas detection systems in the parkades to activate the fans based on carbon monoxide concentrations. Given that the fans are on continuously, a configuration which allows the fans to operate only when required may have a relatively low payback period (less than ten years). It will also result in less frequent fan operation, which in turn would result in a longer service life for the fan motors.

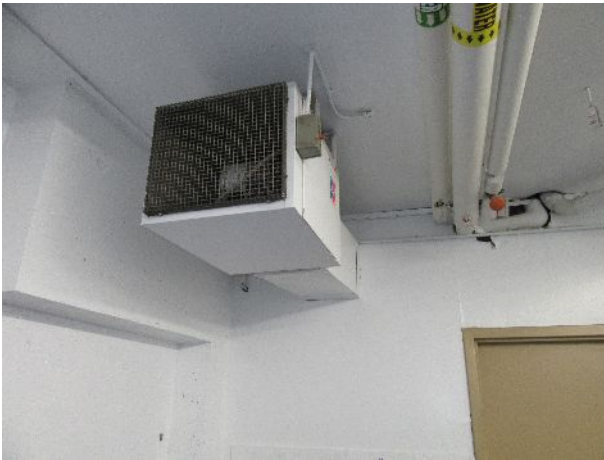
The expected service life relates to the smaller (fractional horsepower) fans which are typically replaced in their entirety. The expected service life is based on our understanding that many of the exhaust fans operate most of the time, but not continuously. The present equivalent age represents the average estimated age of the smaller fans. We expect that the funds required for component replacement or occasional repair of the larger fans, and full replacement of the smaller fans, can be drawn from the operating budget as required.

104 – Garbage room exhaust fan

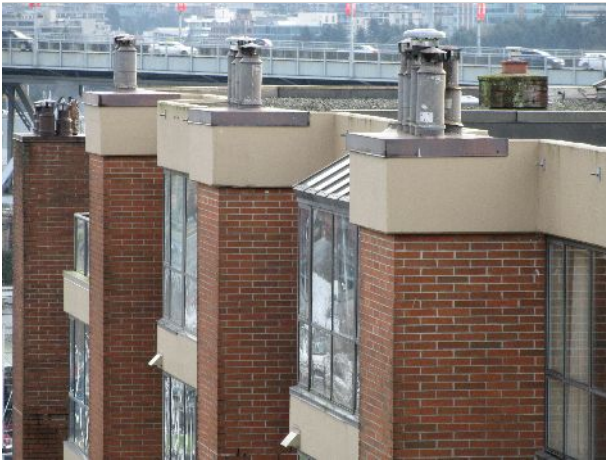
The expected service life, present equivalent age and condition assessment represent an average service life, age and condition of the different vent terminations. We recommend that the fireplace and boiler flues be painted with rust-inhibiting paint every five years to delay replacement of the flues. The strata corporation should also ensure that all flue vent caps are securely fastened to the flues. We expect that the funds for this maintenance work can be drawn from the operating budget without significant impact. The replacement budget is for flue and chimney cap flashing replacement for the entire complex. We do not expect that the remaining vent terminations will require replacement in the next 30 years.

105 – Fireplace flues at top of chimneys

The strata corporation meeting minutes of the last five years indicate that many of the in-slab dryer ducts have been prone to blockages and leaks, likely as a result of being crushed during original construction. The strata corporation has remediated the leaks using crack injection. Given the frequency of crack injection, we expect that the funds required for future leak remediation will be drawn from the operating budget as required. We recommend that the dryer vents (or at the very least the problematic vents) be cleaned annually (with funds from the operating budget) from both the inside and outside to reduce the frequency of blockages and subsequent leaks. The owners could also consider mandating that only ventless dryers be used in suites with problematic dryer ducts.

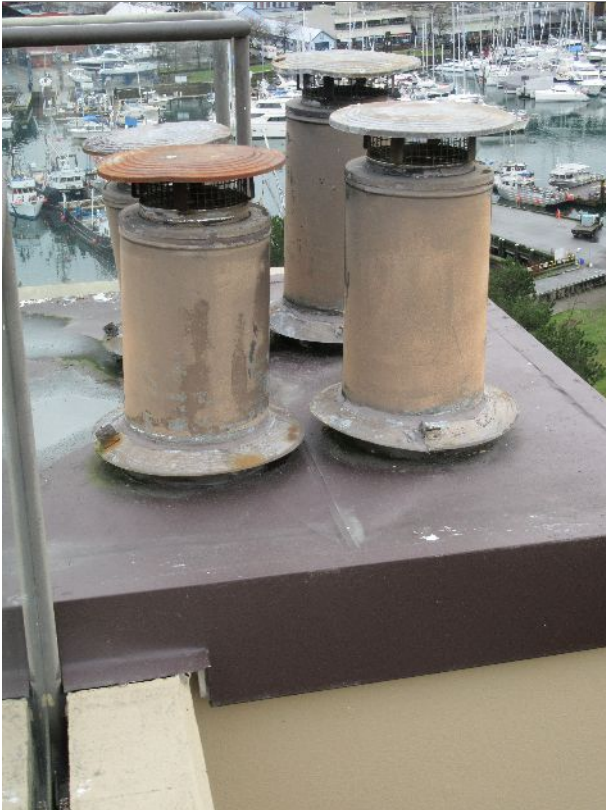
106 – Gas flues at top of chimney

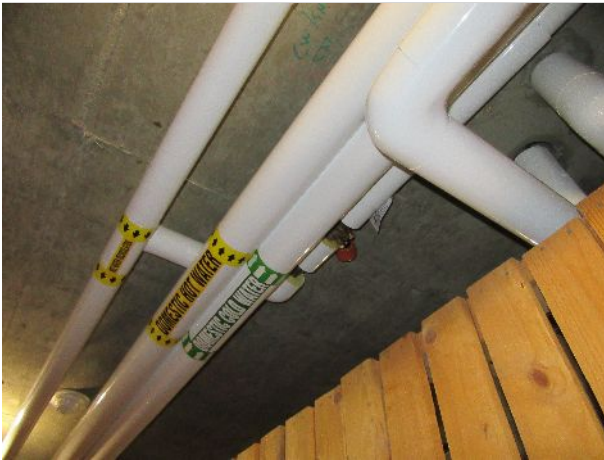
The expected service life represents that of hot water copper piping which has a shorter service life than cold water copper piping. The strata corporation meeting minutes indicate that some leaks have occurred (and been repaired) in the last five years.

107 – Insulated copper piping in storage locker room

A budget has been provided to replace the copper piping of both the hot and cold domestic water distribution system and insulate all of the piping throughout the entire complex. It includes the installation of new isolation valves, restoration of interior finishes and engineering fees. The budget is based on using PEX piping for the branch lines and copper piping for the rest of the distribution system. Given the magnitude of the project cost, the project has been spread out over three years. Instead of piping replacement, the owners could consider engaging a contractor to line the inside of the copper piping with an epoxy coating.

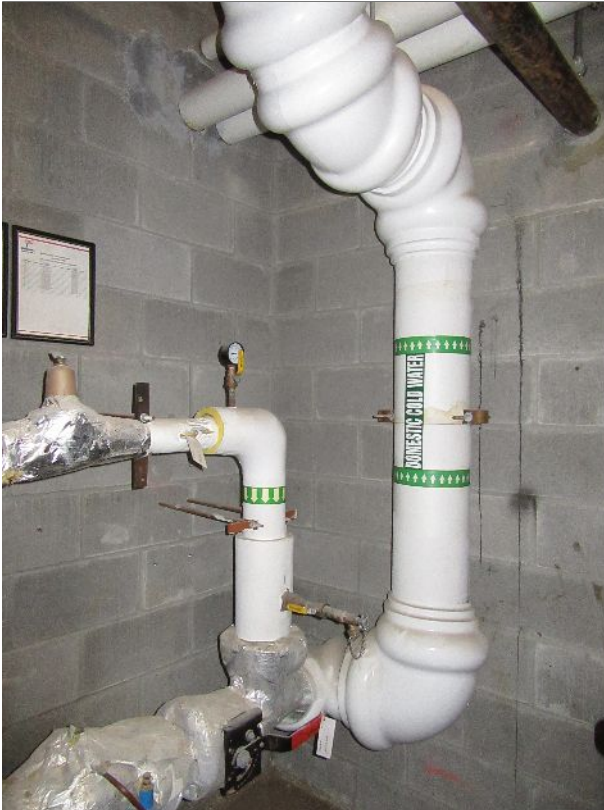
108 – Insulated copper piping in water entry room

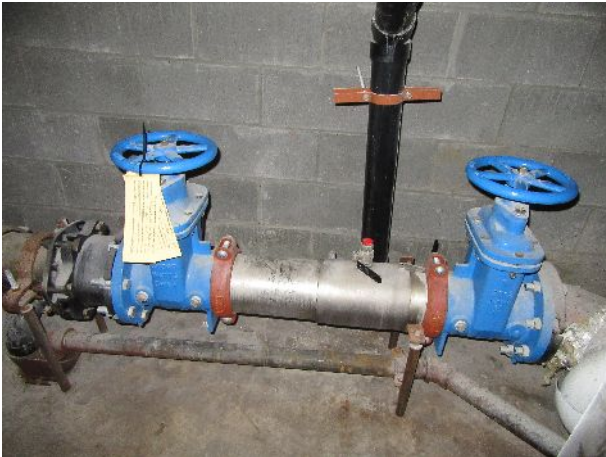
The expected service life and present equivalent age represent the average service life and age of the valves in the complex. In actuality, the service life and age of the valves and backflow preventers vary significantly. We expect that replacement of the smaller valves can be funded from the operating budget as required. A budget has been provided which represents the replacement of approximately two large valves every five years, beginning in the 2017/2018 (five years after two large valves were replaced below Pennyfarthing Drive). The largest valves are typically located in the water entry rooms.

109 – Double check valve assembly

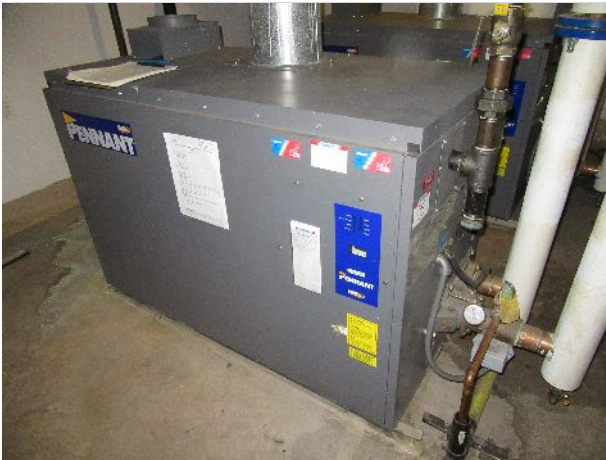
No significant evidence of leakage was observed below the boilers. The strata council meeting minutes indicate that the burners on three of the four boilers have been replaced since 2011. Given that the boilers are similar in age and construction, are subject to similar operating loads, and as a result are likely to have similar service lives, a budget has been provided to replace all of the boilers at the same time. We also believe that some economy of scale can be achieved by consolidating the replacement of the boilers.

110 – Boiler in 1450 rooftop boiler room

The accrued replacement funds could also be used to replace parts or boilers as required. Because these boilers are built with components that can be easily replaced (heat exchanger, aquastats, burners, gas valve, etc.), the service life can be extended with timely repairs and component replacement. If considering replacement, we recommend that two boilers be installed in each boiler room to extend the service life of the boiler plant (if both boilers are properly sized and they operate in an alternating sequence) and to eliminate interruption of service during maintenance and repair work. Alternatively, multi-stage boilers could be installed to improve efficiency and increase redundancy.

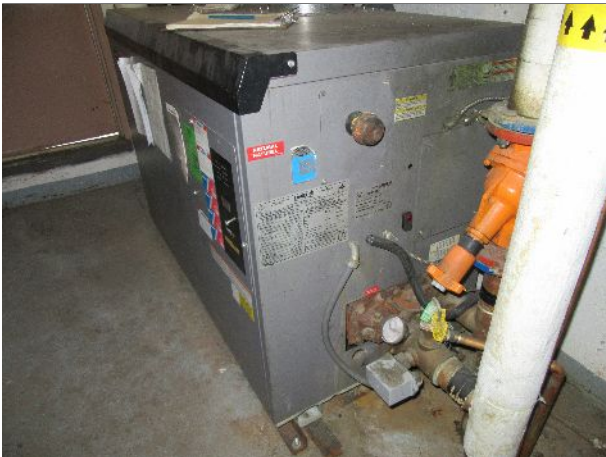
111 – Boiler in 1490 rooftop boiler room

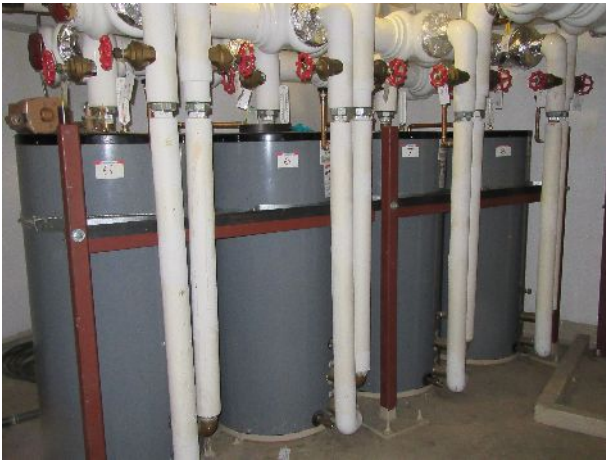
No significant evidence of leakage was observed below the storage tanks. Given that the tanks are similar in age, are subject to similar operating loads and have similar service lives, a budget has been provided to replace all of the tanks at the same time. We believe that some economy of scale can be achieved by consolidating the replacement of the tanks.

112 – Storage tanks in 1450 rooftop boiler room

The anode rods of the tanks should be inspected annually by the strata corporation's mechanical maintenance service provider if this is not already being undertaken. Replacing the anode rods when the inner steel core is exposed will likely extend the service life of the tanks.

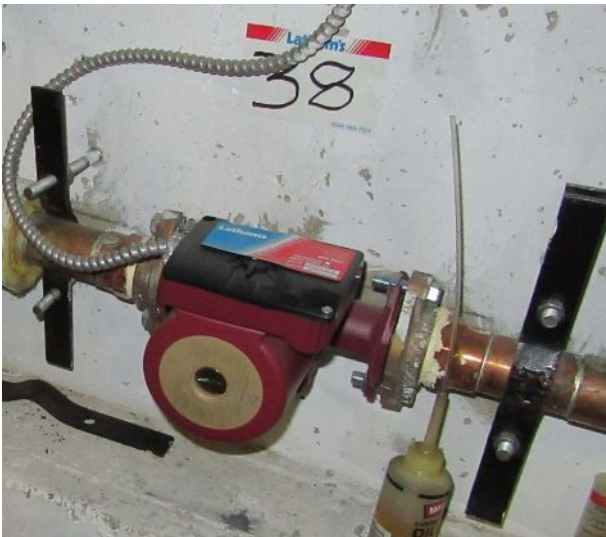
The expected service life and present equivalent age represent the average service life and average age of the circulation pumps in the three boiler rooms. We expect that the operating budget can be used to replace the pumps as required.

113 – Recirculation pump

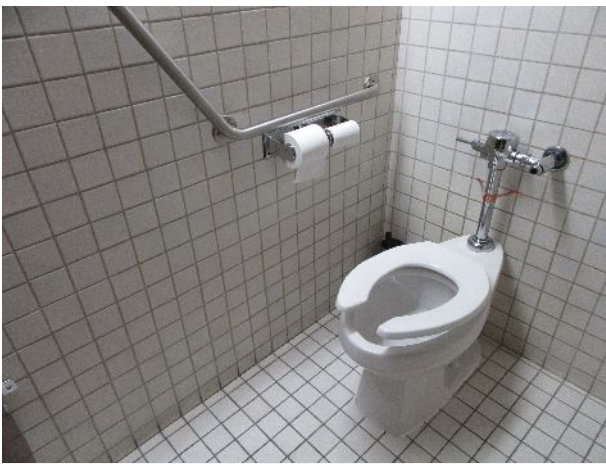
The expected service life, present equivalent age and condition assessment represent the average service life, age and condition of the plumbing fixtures in the complex. Most plumbing fixtures are replaced when the interior finishes are renewed, therefore the budget for replacement of the plumbing fixtures is included in the budget for interior renovations. In the event that a plumbing fixture requires replacement or repair before or after an interior renovation, we expect that the operating budget can be used to fund its replacement or repair. We recommend that the faucets in the men's washroom be replaced or repaired.

114 – Plumbing fixtures in men's change room

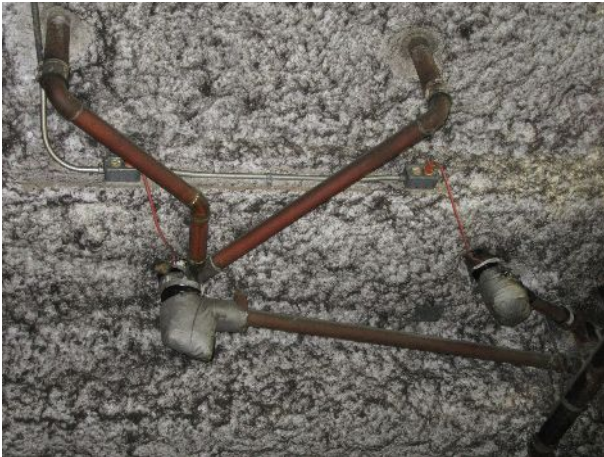
Although no obvious evidence of leaks from the joints or piping was observed, the strata council meeting minutes document that some leaks have occurred over the last five years. We expect that the funds for replacement of the required sections of piping or for the occasional replacement of mechanical joints (on the cast iron and copper piping) can be drawn from the operating budget.

115 – Copper sanitary piping in parkade

Given the use of garburators in many units, a budget has been provided to hydro-flush the vertical plumbing stacks and horizontal piping in the parkade every five years. The strata council meeting minutes do not indicate that (full building) hydro-flushing took place in the last five years, therefore a hydro-flushing is recommended in the first fiscal year of the report.

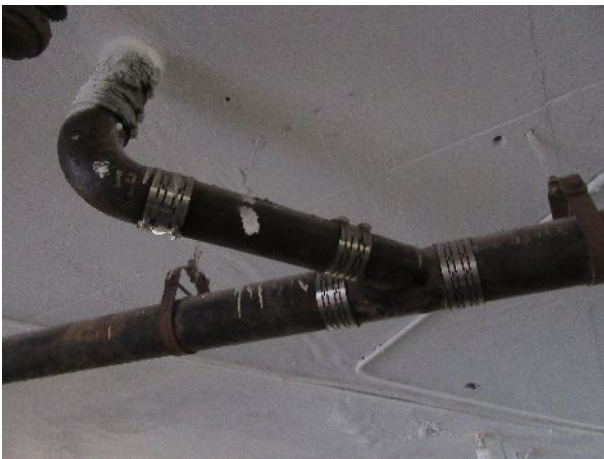
Although no obvious evidence of leaks from the joints or piping was observed where the plastic or cast iron piping was visible, the strata council meeting minutes document that some leaks have occurred over the last five years. We expect that the funds for replacement of the required sections of plastic or cast iron piping or for the occasional replacement of mechanical joints (on the cast iron piping) can be drawn from the operating budget.

116 – Cast iron drainage piping in parkade

A budget has been provided to hydro-flush the vertical and horizontal piping every ten years. We understand that a full-building hydro-flushing took place in 2015, after the parkade restoration project was completed. All drains should be cleared at least annually by owners (roof decks and patios) or by the strata corporation (common areas). We do not expect that the underground piping will require replacement or major repairs in the next 30 years.

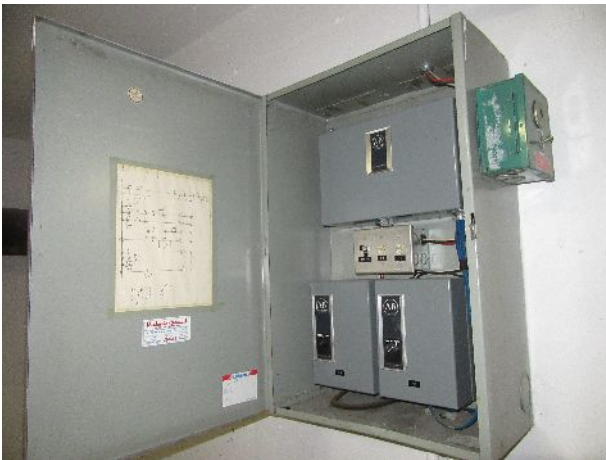
We have assumed that the sump pumps have been replaced once since original construction of the 1450 building (1983). Given that we could not review the pumps, the condition assessment relates to the control panel. We expect that the funds required to repair or replace the pumps can be drawn from the operating budget as required. We recommend that the pumps be tested annually if the mechanical maintenance contractor is not already doing so.

Sump pump control panels are basic devices, often with readily available parts. Consequently, we do not expect the control panel to require full replacement in the next 30 years. In the event that some of the internal components require replacement in the next 30 years, we believe that the required repair funds can be drawn from the operating fund without significant impact.

117 – Sump pump control panel

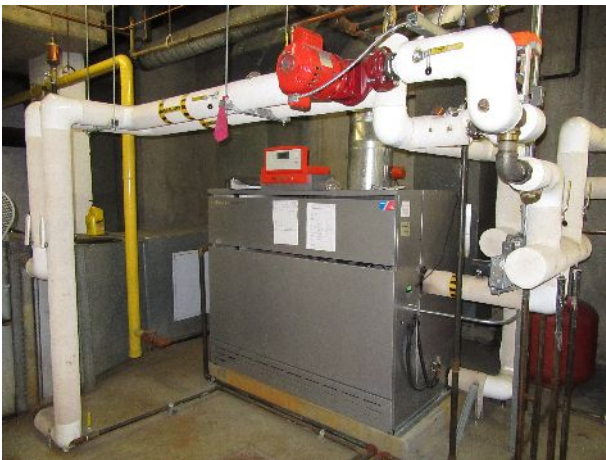
A budget has been provided to replace the boiler. Similar to the automatic circulating tank water heaters, the accrued replacement funds could also be used to replace parts as required. Because the boiler is built with components that can be easily replaced (heat exchanger, aquastats, burners, gas valve, etc.), the service life can be extended with timely repairs and component replacement. We expect that occasional replacement of piping, valves or the circulation pump can be funded from the operating budget.

118 – Viessmann pool and hot tub water heating boiler

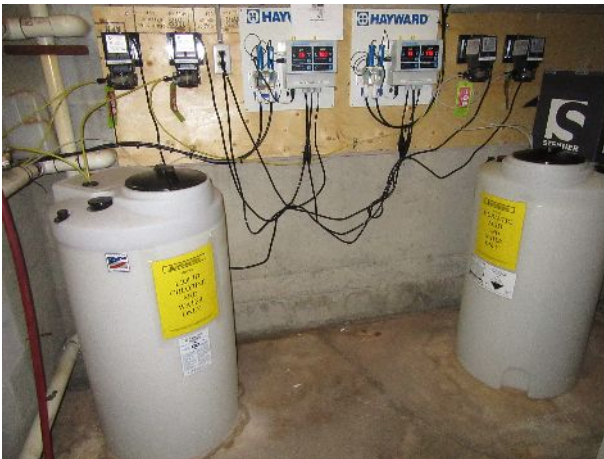
The expected service life, present equivalent and condition assessment represent the service life, age and condition assessment of the automatic water chemistry control system. A budget has been provided for replacement of this automatic water chemistry control system. The budget is based on the costs incurred in 2015. We expect that occasional replacement of the piping, valves, filter and pump can be funded from the operating budget as required without significant impact.

119 – Chlorine generation and pH control system

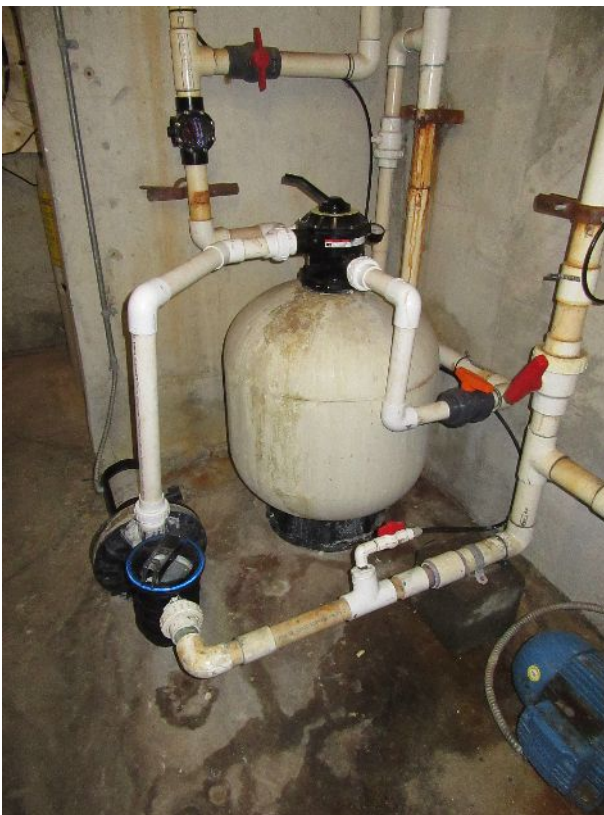
Given that the automatic water chemistry control system has already been addressed elsewhere in this appendix, the expected service life, present equivalent age and condition assessment represent the average service life, age and condition of the sand filter and two pumps. A budget has been provided to replace the sand filter. We expect that the funds required for occasional replacement or repair of the piping, valves or pumps can be drawn from the operating budget as required without significant impact.

120 – Sand filter and pumps for hot tub

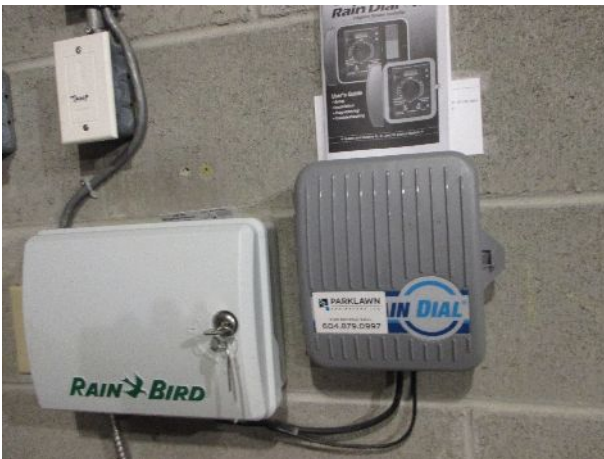
The expected service life represents what we believe to be the average service life of the various components which make up the irrigation systems. The present equivalent age and condition assessment relate to the visually accessible components of the irrigation system, such as the sprinkler heads and controllers.

We do not believe that the irrigation system will require full replacement or significant repairs in the next 30 years. Occasional replacement of the controllers, control valves and sprinkler heads, as well as repairs to broken supply lines will likely be required over the next 30 years. We expect that the funds for component replacement or repairs can be drawn from the operating budget as required without significant impact. If not already installed, we recommend that rain sensors be incorporated into the systems to ensure that the sprinkler systems do not water the exterior grounds when not required.

121 – Irrigation system controller

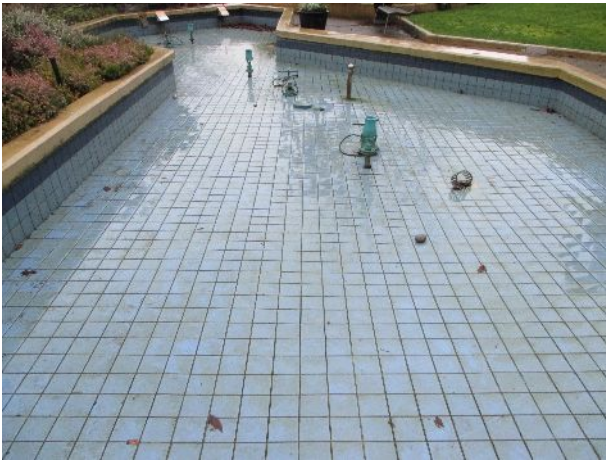
The expected service life, present equivalent age and condition assessment represent an average service life, age and condition of the various mechanical components of the water feature. We expect that occasional repairs or component replacement can be funded from the operating budget without significant impact.

122 – Water feature in courtyard

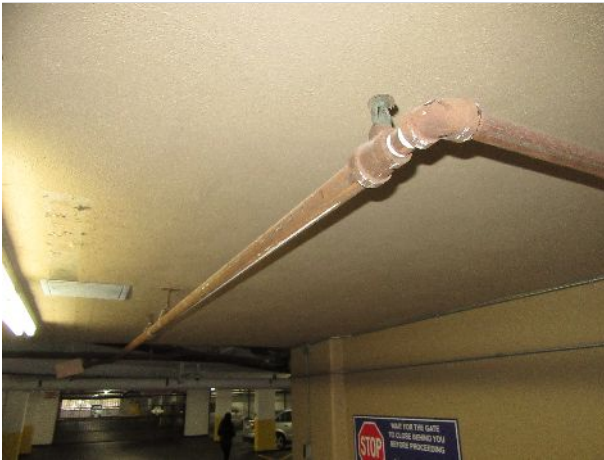
Although we do not expect full replacement of the piping in the next 30 years, some leaks are likely to occur due to internal corrosion. The strata corporation meeting minutes document that sprinkler piping leaks have occurred in the last five years. A repair budget has been provided to replace some pipe segments. This has been approximated to occur every five years on average, beginning five years after the last known sprinkler pipe segment replacement (2012).

123 – Dry pipe sprinkler system piping and head

The National Fire Protection Association (NFPA) standards referenced by the BCFC require that dry pipe sprinkler heads be tested every ten years and wet pipe sprinkler heads be tested after 50 years of service. We recommend that the strata council discuss testing and replacement with the fire protection service provider.

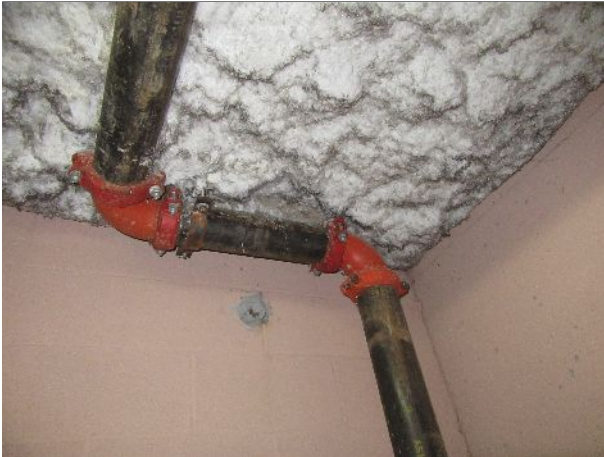
124 – Sprinkler piping in bicycle storage room

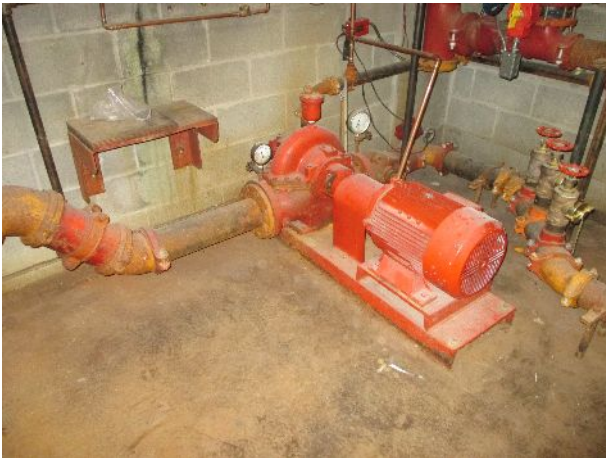
The service life is based on the pump's infrequent use. The replacement budget includes both the fire pump and the control panel. We expect that replacement of the jockey pump, jockey pump control panel or occasional repairs to the pumps and control panels can be drawn from the operating budget without significant impact.

125 – Fire pump in 1450 water entry room

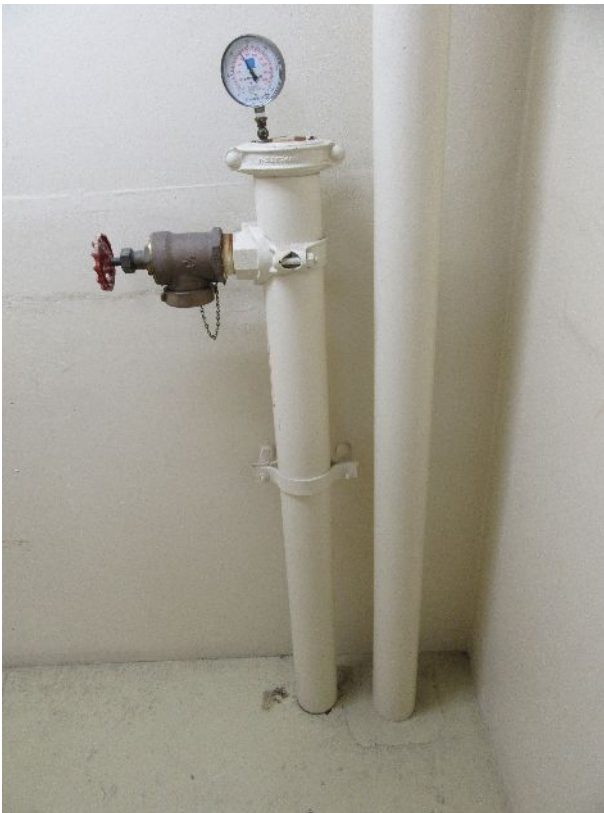
The strata corporation meeting minutes indicate that deficient fire hoses were replaced in 2011. A repair budget has been provided to replace additional deficient fire hoses at ten year intervals and the budget is based on the costs incurred in 2011. We expect that the operating budget is used to fund the required replacement of valves, fittings or couplings after each annual BC Fire Code inspection.

126 – Wet standpipe connection in stairwell

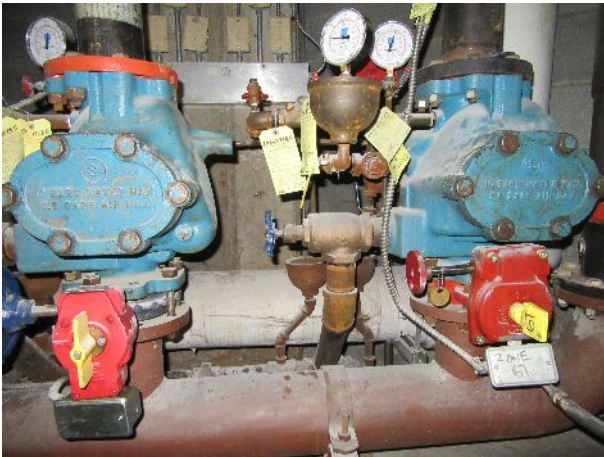
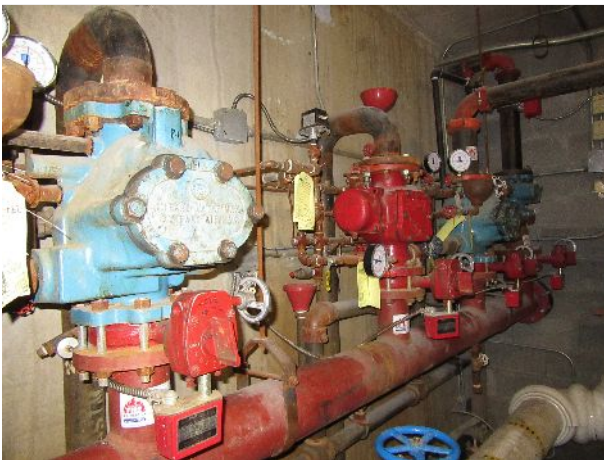
127 – Clapper valves in 1490 water entry room

128 – Clapper valves in 1470 water entry room

A budget has been provided to replace the eight clapper valves at the same time. The service life of the clapper valves can likely be extended by replacing the rubber seals on the clapper if leaks begin to occur.

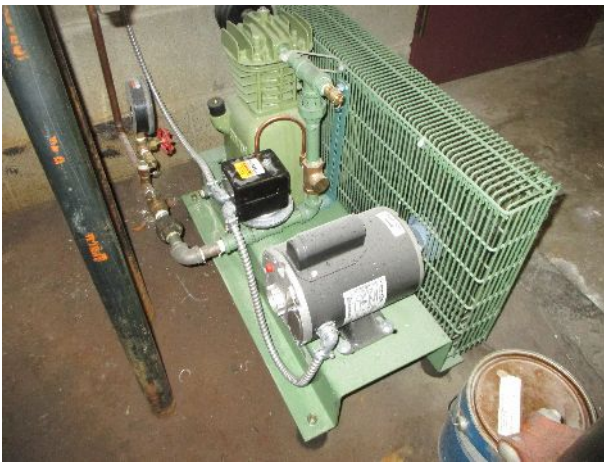
The present equivalent age and condition assessment represent the average estimated age and condition of the three air compressors. We understand that the 1470 compressor was replaced circa 2008. A budget has been provided to replace the 1490 compressor in two years, the 1470 compressor in 20 years and the 1450 compressor in 27 years. The replacement budget for the 2045/2046 fiscal year is for replacement of the 1490 air compressor.

If air leaks exist in the dry pipe sprinkler system piping, the compressor will be activated more frequently to continually pressurize the system and this will result in a decreased service life for the compressor. The owners should test the dry pipe sprinkler piping for leaks if the compressor begins to run more frequently.

129 – Dry pipe sprinkler system air compressor in 1450

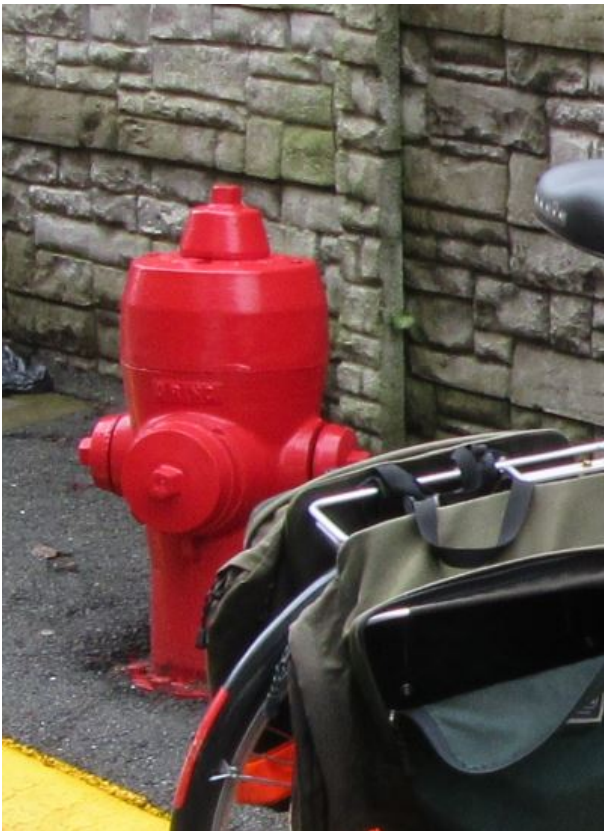
We understand that the fire hydrants are inspected and serviced based on the requirements of the BC Fire Code (hydrants inspected and flow-tested annually, piping flow-tested every five years, etc.). We do not expect that the fire hydrants or underground piping which connect them to the municipal water supply will require replacement or significant repairs in the next 30 years. We assume that the funds required for repainting can be drawn from the operating budget without significant impact.

130 – Fire hydrant adjacent to Pennyfarthing Drive

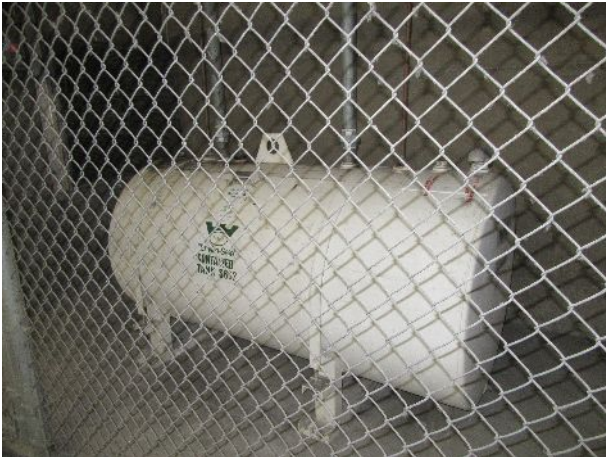
We do not believe that the day and bulk storage tanks will require replacement in the next 30 years. We expect that the repair or replacement of the fuel transfer pump or fuel lines can be funded from the operating budget without significant impact.

131 – Main fuel storage tank next to generator room

Diesel fuel has a limited storage life depending upon initial fuel quality, contaminant levels, and storage conditions. To extend fuel life, it is recommended that periodic filtering and treatment of the fuel be conducted to remove water, scale, and bacterial growth. We recommend that the fuel be tested (and polished and filtered if required) during the annual emergency generator inspection and testing. Use of clean fuel will increase the likelihood that the generator will reach its expected service life.

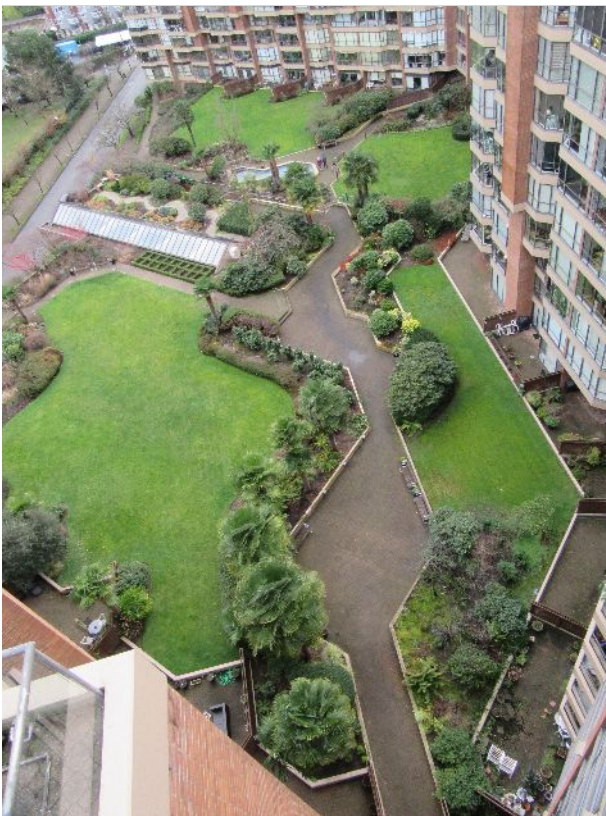
132 – Exterior grounds over parkades

within the suspended slab will eventually begin to corrode and, if left unattended for an extended period of time, may weaken to the point of failure. In the shorter term, ongoing corrosion of the reinforcing steel increases the likelihood of spalling concrete (which could damage vehicles and cause personal injury). Deferring remediation of the leaks increases the likelihood of future reinforcing steel repairs.

Epoxy crack injection is often undertaken to stop nuisance leaks and prevent them from damaging vehicle finishes, but it does not address the root cause of the issue. The best way to remediate leaks through the suspended slab is from above the parkade, but depending on the number of leaks, isolated leak remediation from above may not be worthwhile if full replacement of the membrane is more cost effective or the membrane has almost reached its expected service life, which we believe is the case for this building.

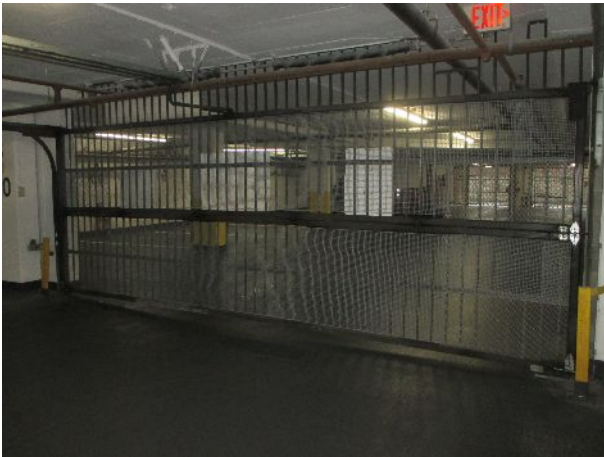
133 – 1470 parkade gate

The parkade entrance and exit to and from the 1470 building's visitors parking area are secured with picketed aluminum swing gates. The other parkade entrances are secured with two-piece, picketed aluminum overhead gates. The strata corporation meeting minutes indicate that one of the overhead gates for a parkade accessed from Creekside Drive was replaced in 2014 as a result of an accident.

The present equivalent age and condition assessment represent an average age and condition for the parkade gates. A budget has been provided to replace a parkade gate every five years beginning in the 2035/36 fiscal year. We expect that repairs or replacement of parts (torsion spring, hinges, pulleys, etc.) can be funded from the operating budget without significant impact.

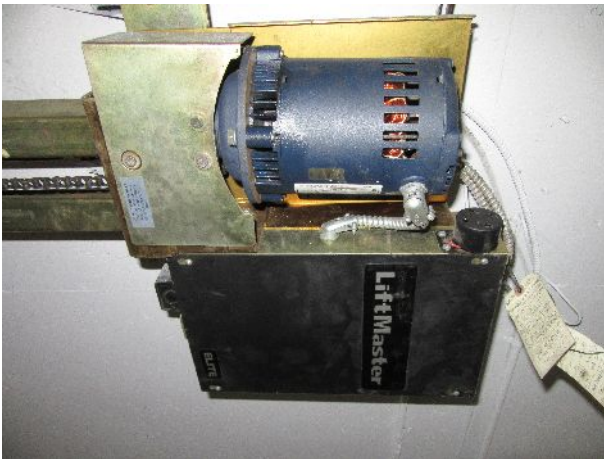
134 – Overhead gate operator

The entry and exit of the visitor parking area accessed from Pennyfarthing Drive are secured with swing gates operated by Liftmaster operators. The strata corporation meeting minutes indicate that one of the swing gate operators was replaced in 2011. The remaining parkade gates are overhead gates operated by Manaras and Liftmaster operators. The 1470 overhead gate is operated by an operator manufactured in 2007.

The indicated service life is an average of the service life of the overhead gate operators and the shorter service life of the swing gate operators (due to more frequent use). The present equivalent age and condition assessment represent an average age and condition of the parkade gate operators. A budget has been provided to replace a parkade gate operator every five years beginning in the 2025/26 fiscal year. The budget is an average replacement cost of the swing gate operators (more expensive) and the overhead gate operators (less expensive). Until replacement occurs, we expect that replacement parts will be readily available for repairs and the cost for repairs will not exceed half of the value of a new operator. We expect that the funds for repairs can be drawn from the operating budget.

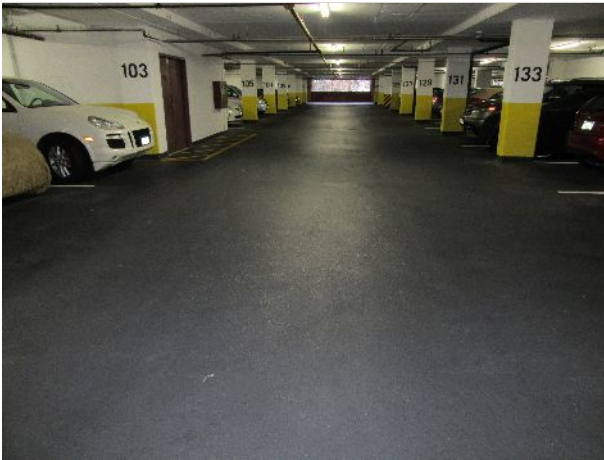
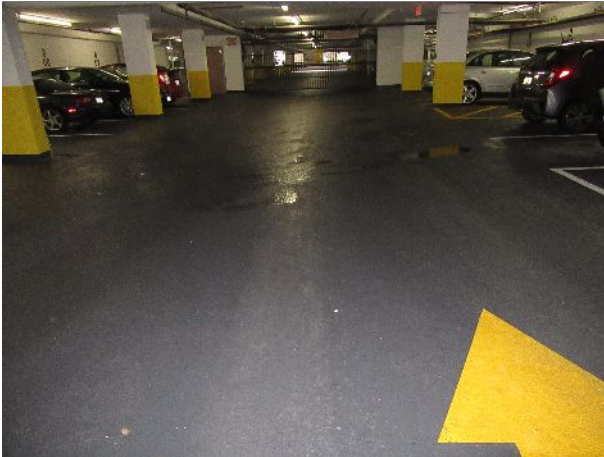
A polyurethane traffic deck coating (TDC) system was applied to the suspended slabs of the parkades in 2014. Previous to this project, there was no TDC in the parkade. The base coat of the TDC system is 30 mil (thousandths of an inch) thick. The wear course (applied over the base coat) is 18 mil thick in stalls, 25 mil thick in drive lanes and 35 mil thick in turning areas.

If the wear course of the TDC system is re-applied regularly, we do not expect that the full TDC system will require replacement in the next 30 years. A renewal budget has been provided to re-apply the wear course to the drive lanes every ten years after original application of the TDC system. The budget includes a small allowance for some concrete restoration work. A second renewal budget has been provided to re-apply the wear course to the parking stalls every 15 years after original application of the TDC system. This budget also include a small allowance for some concrete restoration work.

Approximately one year prior to each TDC renewal project, we recommend that an assessment be undertaken to determine the extent of the concrete restoration work. A budget has been provided for these assessments. The TDC system comes with a five year warranty. Another assessment budget has been provided for this warranty review, one year prior to the expiry of the warranty. The warranty review budget also includes updating the 2013 RJC Parking Structure Evaluation.

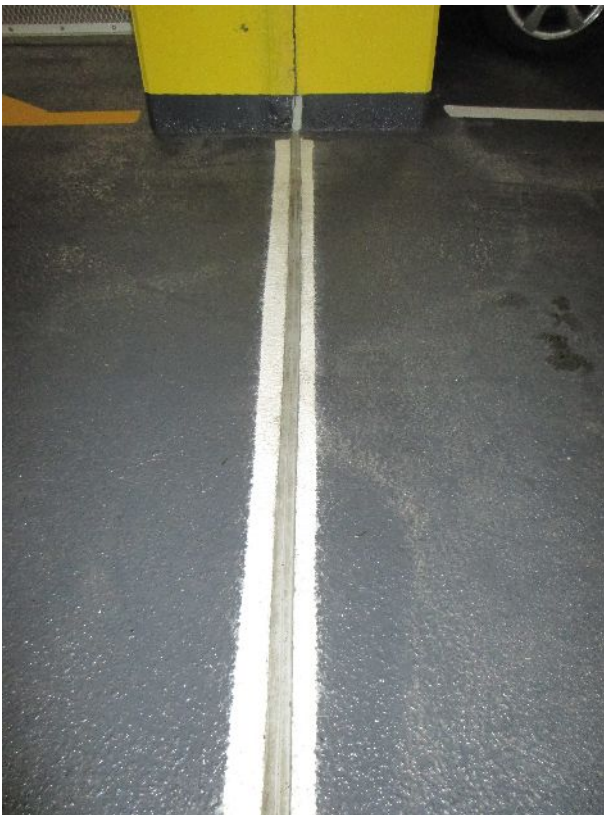
137 – Expansion joint in 1450 parkade

A portion of the expansion joint seals in the parkade were replaced during the 2014 parkade restoration project with a low density closed cell joint seal that is bonded to either side of the joint. The remaining expansions joint seals date from original construction.

The service life, present equivalent age and condition assessment relate to the original expansion joint seals. We recommend that the original expansion joint seals in the parkade be replaced when the wear course of the traffic deck coating is first renewed. Doing so will likely reduce the cost of the project slightly. A budget has been provided for this work.
