# Harbour Cove Depreciation Report

1450, 1470 & 1490 Pennyfarthing Drive, Vancouver, BC

Draft Report: August 10, 2016

Final Report: May 2, 2017

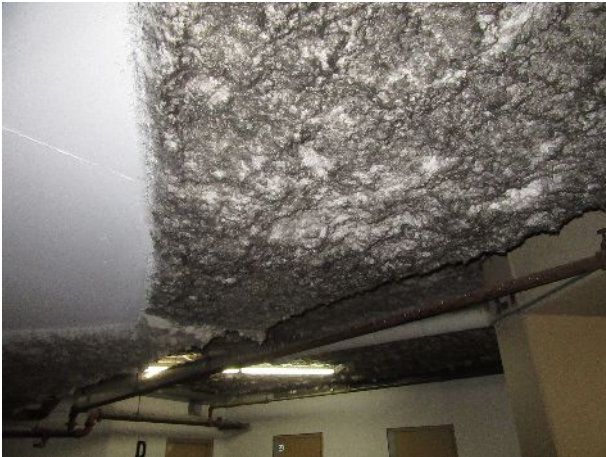
138 – Spray-applied insulation in parkade

We do not expect that the spray-applied insulation will delaminate from the underside of the concrete slabs in the next 30 years. Some insulation has been removed to allow for crack injection in the parkades. We expect that the funds required to reinstate this insulation can be drawn from the operating budget.

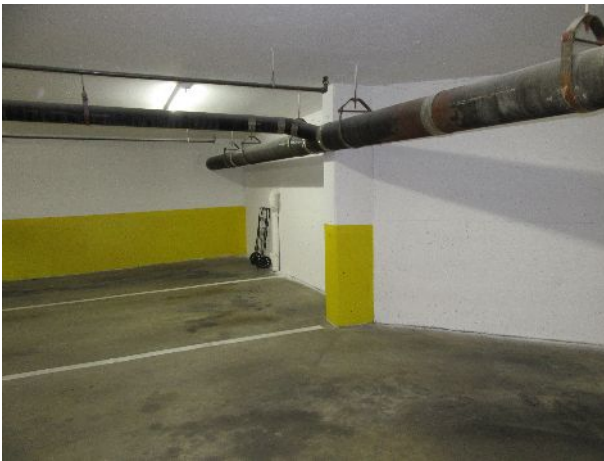
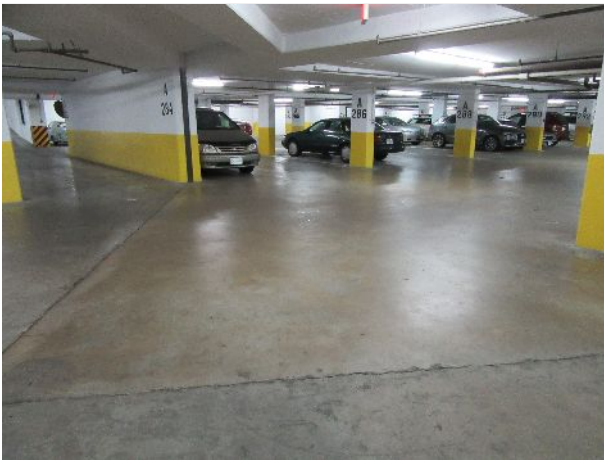
The parkade walls, columns and ceilings are painted. The parkade was re-painted during the traffic deck coating replacement project in 2014.

A budget has been provided to re-paint the parkades in a colour scheme similar to the existing one. The budget also includes painting the security screens, parkade doors, stall numbers and line painting.

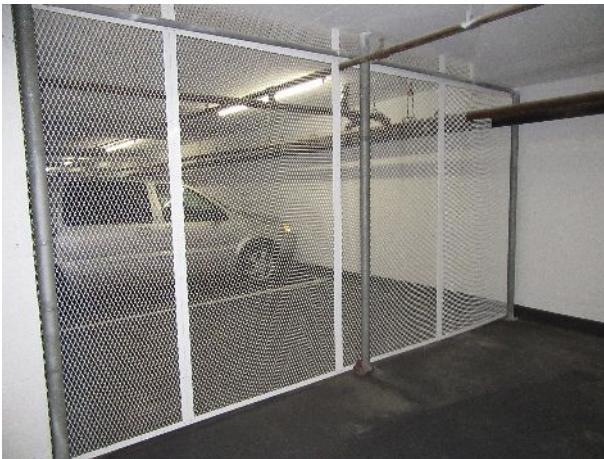
142 – Metal mesh security screen

We do not expect that the metal mesh and chain link fencing security screens will require replacement or major repairs in the next 30 years. The budget to re-paint the security screens is included in the re-painting budget for the parkades.

We recommend that the posts for the chain link security screens be reviewed annually by the building manager to ensure that the baseplates (in particular the bottom baseplates secured to the brick) are securely anchored and the fasteners have not corroded to the point of failure. One of the bottom baseplates was not anchored. We recommend that the building manager secure the baseplate to the brick sill.

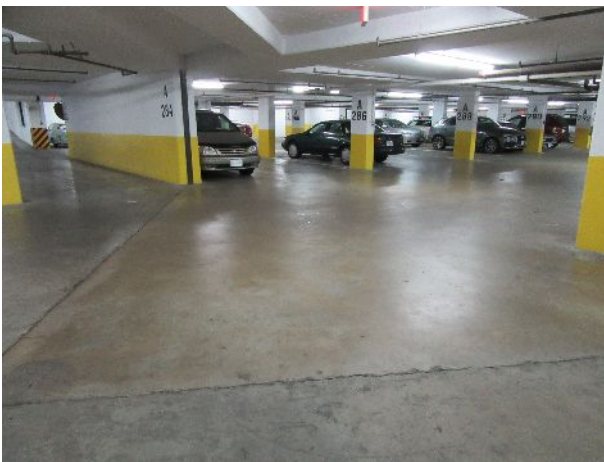
143 – Slab-on-grade

Only minor cracks were observed in the slabs-on-grade. We do not expect that they will require full replacement or significant repairs in the next 30 years.

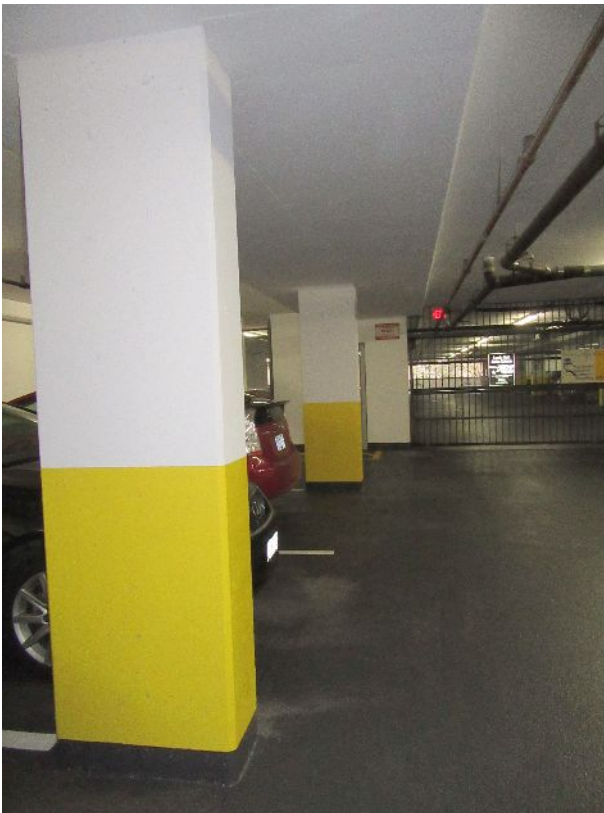
145 – Slab band supported by concrete columns

RJC evaluated the parkade structure in 2013 and provided consulting engineering services during the 2015 parkade restoration project. The restoration work and traffic deck coating done in 2015 will significantly reduce the rate of structural deterioration in the future. The budget to assess the concrete structure before each re-application of the traffic deck coating (TDC) is included in the Parkade appendix. The budget to renew the TDC includes a small allowance for some concrete restoration work.

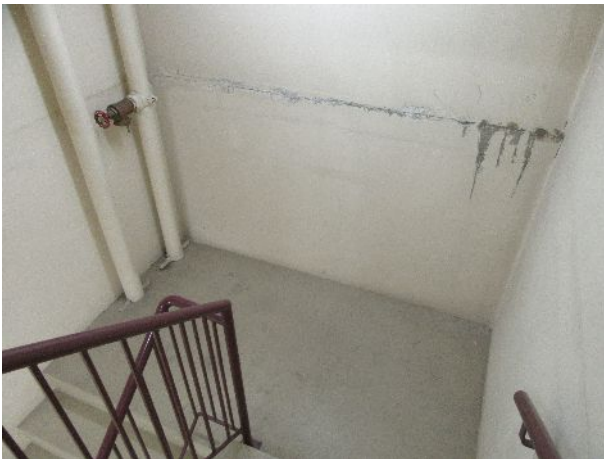
146 – 1450 stairwell wall

Deterioration of a horizontal cold joint (in the concrete) was observed in the 1450 stairwell (refer to photo). As opposed to the parkade structure, most of the building structure is covered by interior finishes, brick veneer or roofing. As a result, the visual assessment of the building structure is inherently limited in nature. The evaluation of building structure is based on a review of the exposed structure in stairwells, balconies and service rooms, and non-structural building elements which are most impacted by structural distress (interior finishes, sealants, door openings, etc.). We did not observe significant evidence that would indicate structural distress and do not believe that the structure will require major repairs or replacement in the next 30 years.
