Harbour Cove Depreciation Report

1450, 1470 & 1490 Pennyfarthing Drive, Vancouver, BC

Final Repo : May 2, 2017

RJC Project: VAN.103675.0022

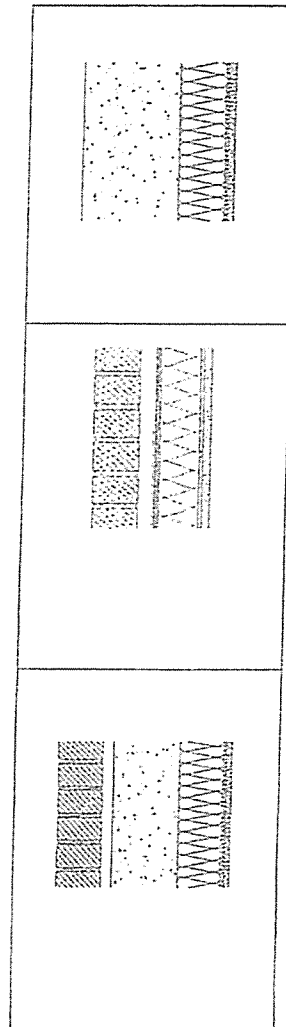
- > Brick veneer
- > 1" air space
- > 5 1/2" concrete wall
- > 3 5/8" steel studs
- > Batt insulation*
- > Polyethylene vapour barrier
- > 1/2" gypsum wallboard w/paint finish

In general, the exposed concrete and masonry walls are in good condition with some localized cracks and minor spalling at the concrete spandrels, and minor efflorescence.
