Layton Consulting was retained by the strata at Harbour Cove, 1470 Pennyfarthing Drive, Vancouver, BC to investigate the existing window system at the same address. Layton Consulting is an engineering consulting firm specializing in glazing and cladding design.

This report was prepared to assess conditions of the original windows and to determine whether or not the existing windows need remediation and/or replacement. An on site meeting and review of the windows was conducted on June 17, 2010. Eric Skytte, ASCT of Layton Consulting and the strata council were present at the review. *This report is mostly limited to the structural integrity of the windows only.* Existing water ingress, caulking or sealant issues are not reviewed to a great extent due to the visual only review.

Figure 1 – Site overview, Harbour Cove, 1470 Pennyfarthing Dr, Vancouver

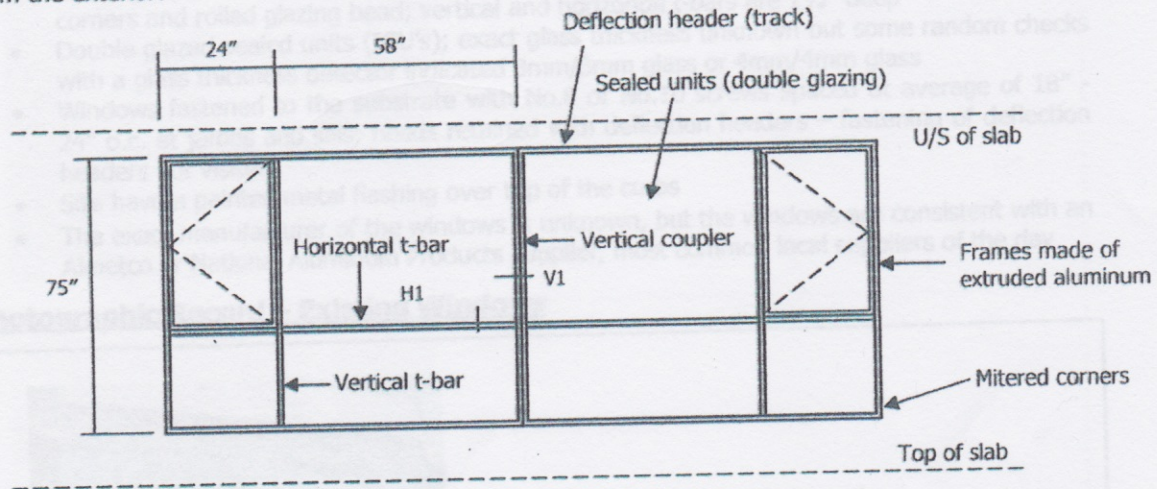
Figure 2 - Typical window elevation

a) Sizes and composition - Typical window heights are approximately 75" high; the overall widths vary depending upon how many panels are coupled (joined) together. Each window is composed of vertical mullion t-bars, and vertical couplers which connect individual window panels together to form a continuous run of windows. The horizontal mullions support the weight of glass and all of the components together (vertical + horizontal frames and glass) support the wind loads.

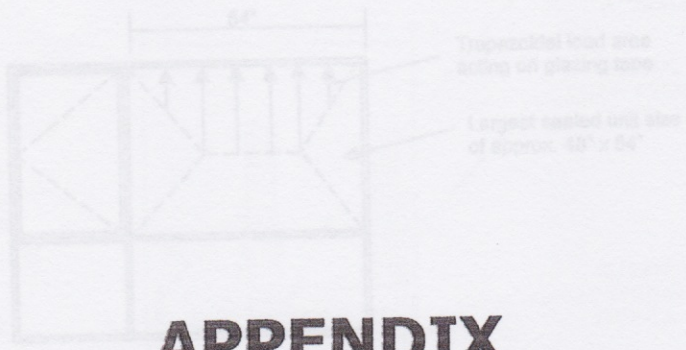
I. FASTENING CALCULATIONS - GLAZING TAPE
1. CALCULATE BITE WIDTH REQUIRED FOR TAPE:

Conclusion – The typical glazing tape should have a width of at least 0.47" (1/2"), however with the bleed out at many of the units, the actual bonding width of the tape still inside the frame is less than this amount. The seals may already be in the process of rupturing at these locations and will continue to do so, leading to further water ingress

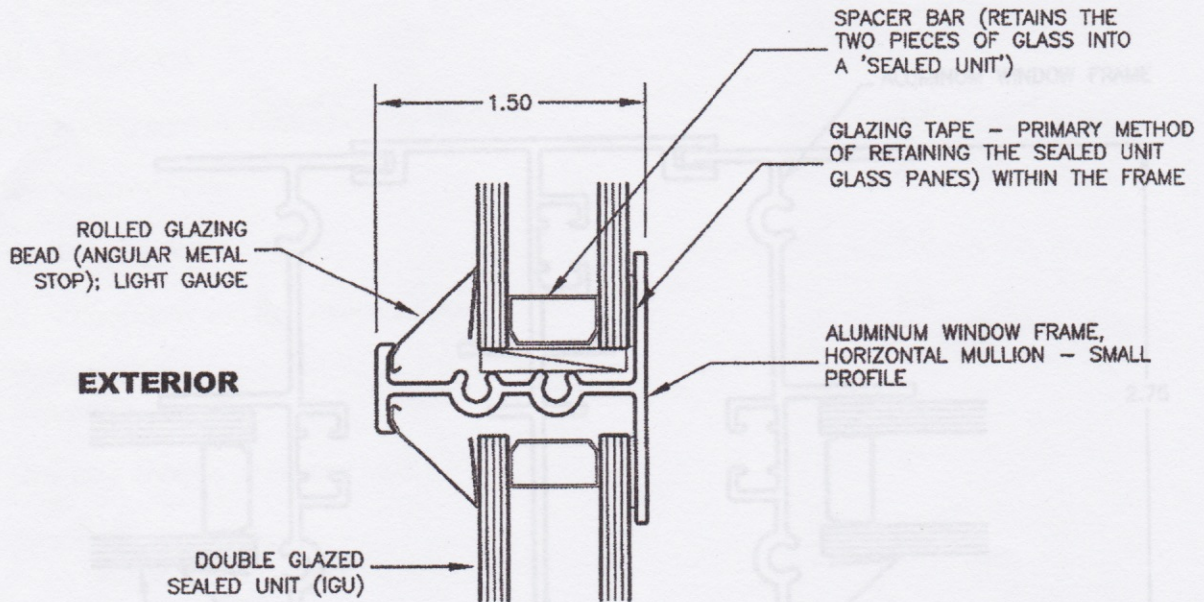
HORIZONTAL T-BAR MULLION PROFILE OF EXISTING WINDOWS

Older window systems, such as on Harbour Cove, utilize window frames that are smaller and less rigid than current 'window wall' systems of today. As such, older windows can be more prone to flex under large wind loads. This flexibility causes greater stress of the seals, leading to potential air and water leaks, creating a shorter life expectancy of the windows as compared to an engineered system of today. Also note that in the 1980's, there was no requirement for the engineering of the window system as is required today. As such, a contractor would select the windows based upon the project specifications, but no structural review was required.

ASSUMED CROSS SECTION (Exact profile may differ)

Material: Aluminum Deflection limit = L/175
(As per codes and standards)

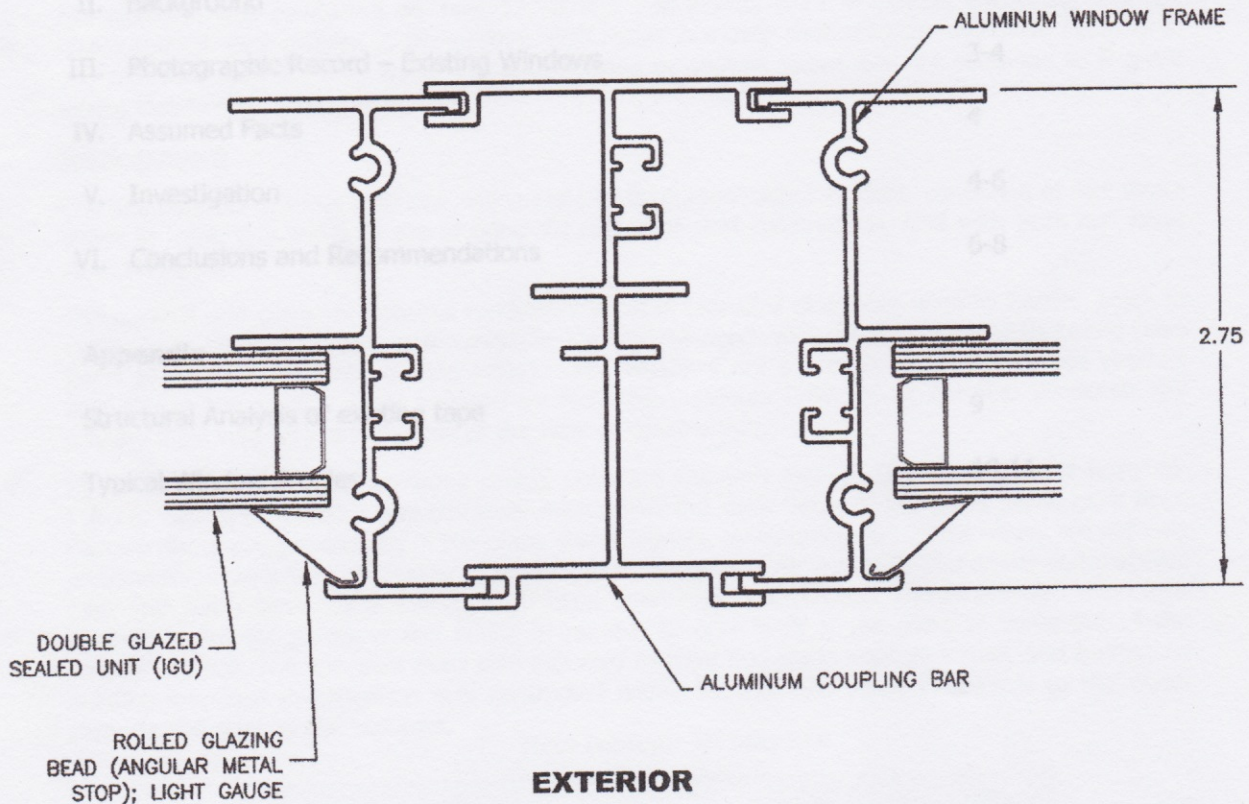
ASSUMED CROSS SECTION IN PLAN VIEW (Exact profile may differ)

Material: Aluminum Deflection limit = L/175
(As per codes and standards)
